JTC Engineering Investigation Upper Idler Gear Idler Shaft Expanding from Martensite Formation

By: Jessica Nicholson

Date Opened: 09/24/2021

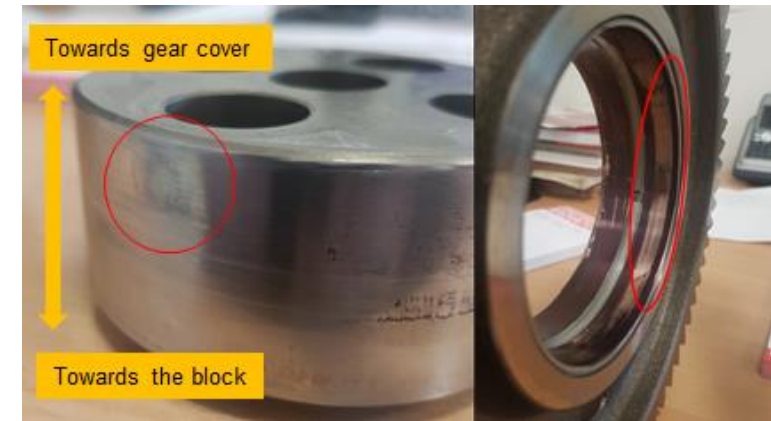
Failing Component and Effects

- **UIG idler shaft fails**
- Retained austenite within idler shaft transitions to martensite over time when preload is applied to bolts
- Effects of failure
 - Martensite formation causes material expansion, diameter increases
 - Clearance between idler shaft and bushing narrows
 - Hydrostatic oil film narrows and eventually closes
 - Lack of oil film causes system failure
- Failure occurred in both single and dual-cam systems until a solution was implemented for single-cam systems
 - Heat treatment procedure altered to decrease retained austenite, reduce failure

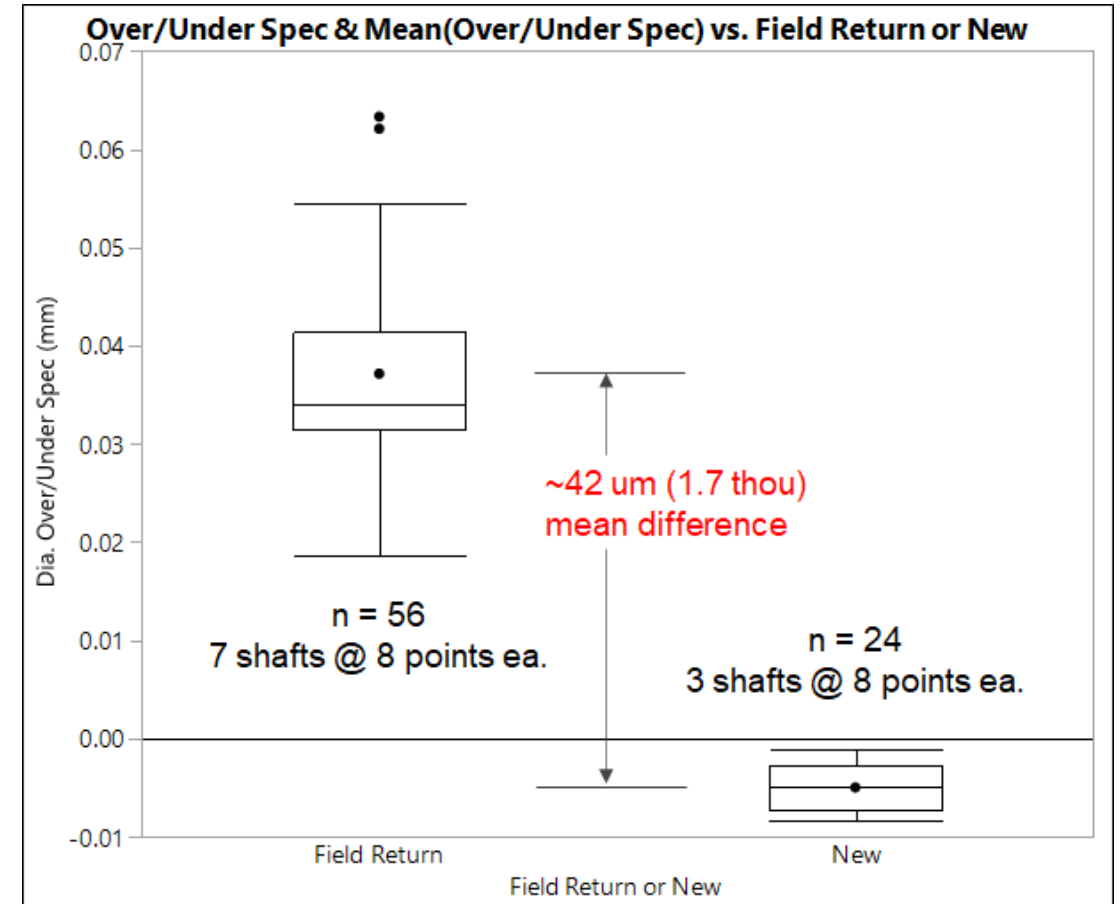
Single-Cam Idler Shaft Failure Before Solution

- Chart of new vs returned single-cam idler shaft diameters
- Before heat treatment change, returned idler shafts had a greater measured diameter than new parts
- Compare these results to diameter measurements of new single-cam idler shafts that have been in service for a significant time
 - Smaller diameter growth and fewer field returns expected

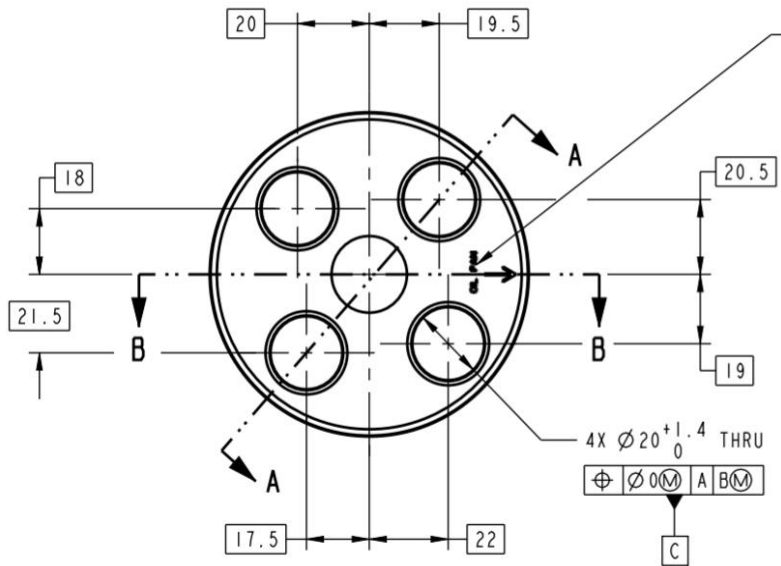
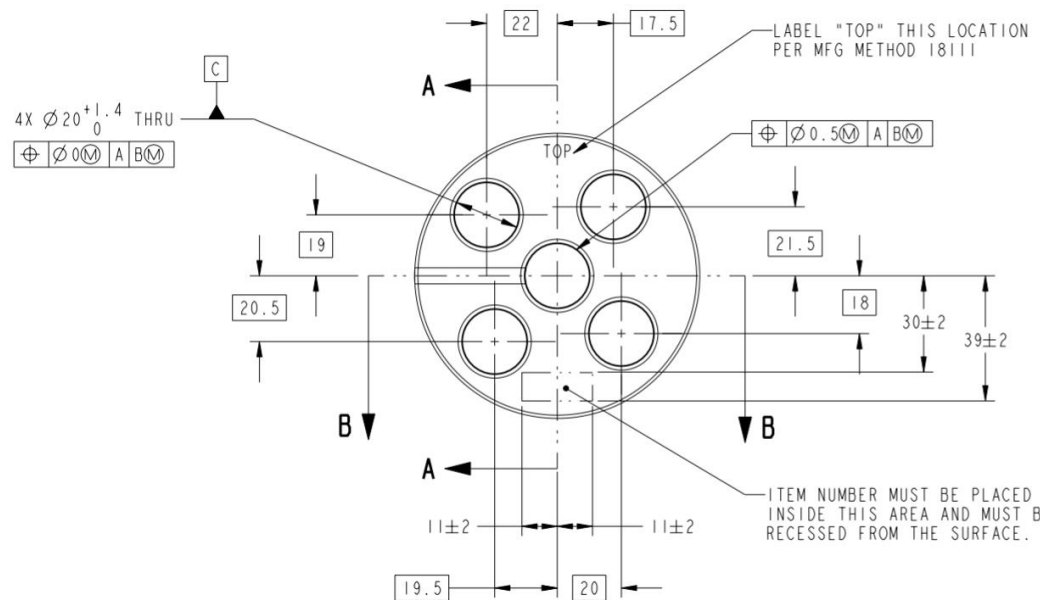
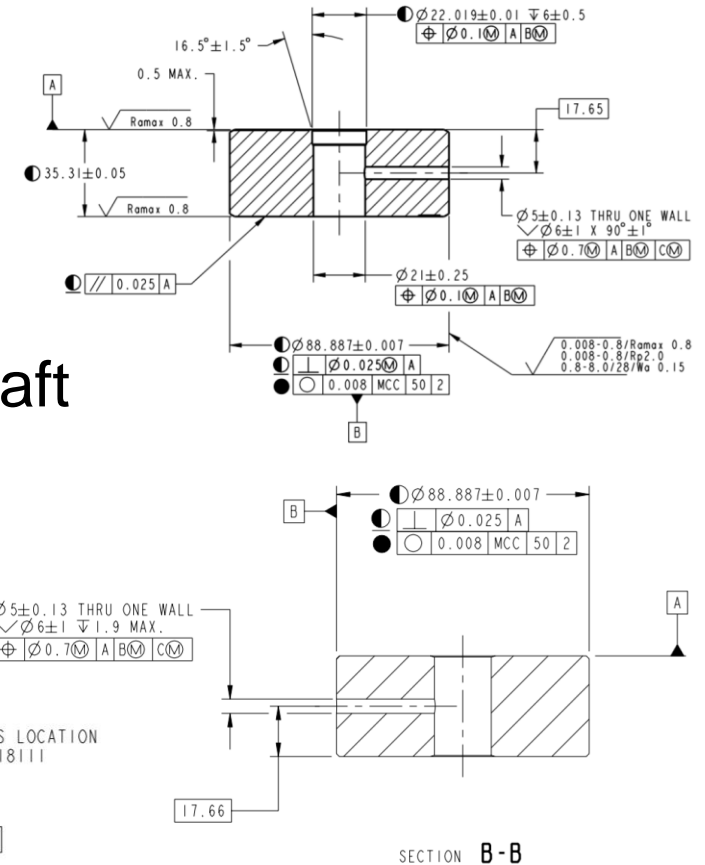
- Key variations between single vs dual-cam UIG idler shaft
 - Center hole diameter larger by 1 mm
 - Center hole structure, counterbore present for dowel ring
 - No chamfer on center hole

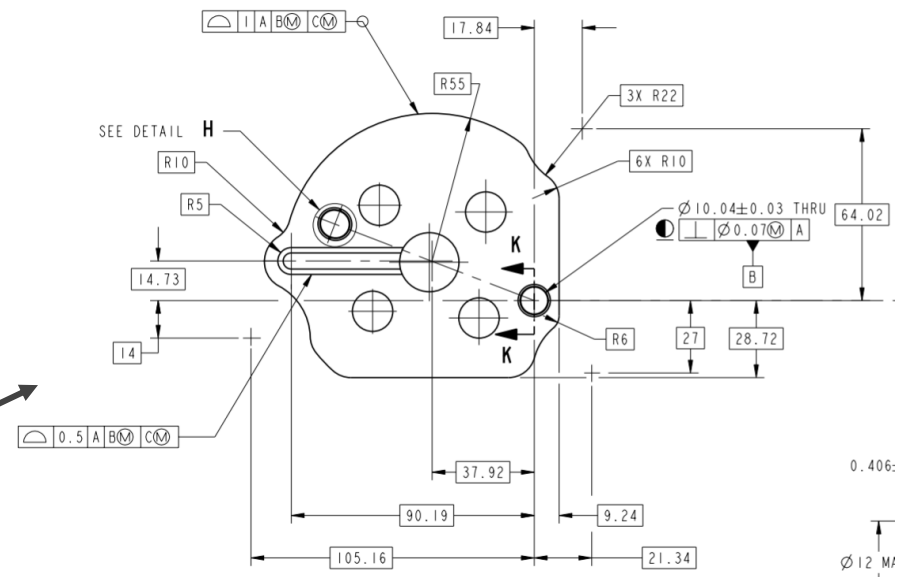
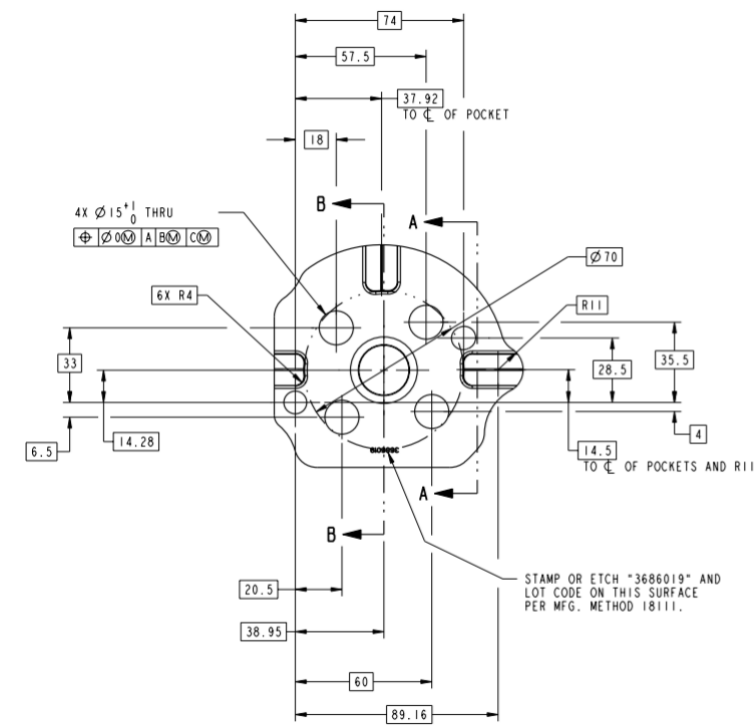
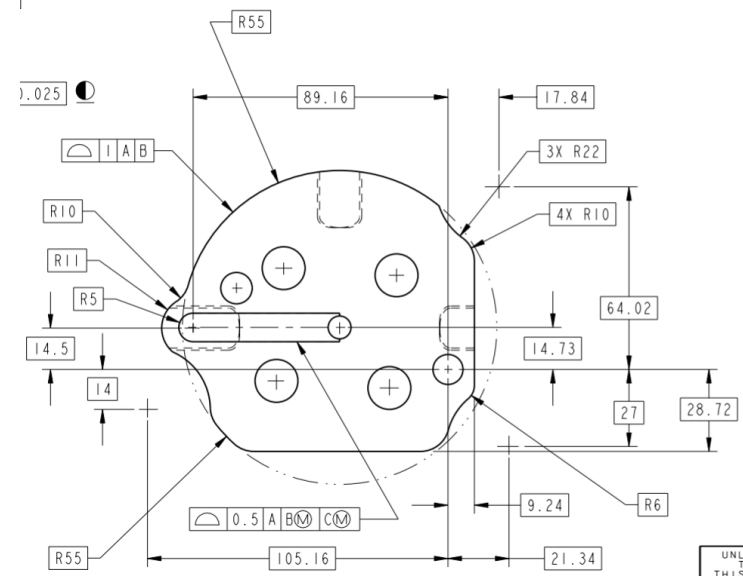
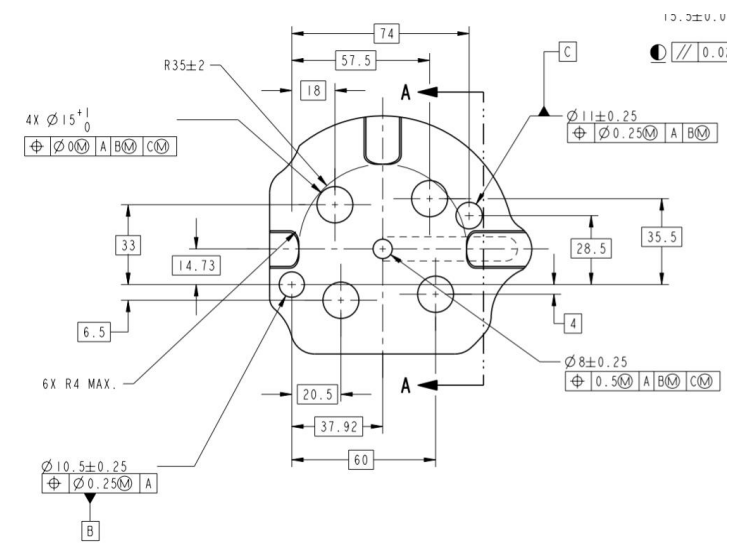
- Key variations between single-cam vs dual-cam UIG mounting spacer
 - Relative positions of all holes the same, except for all holes to center hole
 - Length of oil feed differs by 1 mm

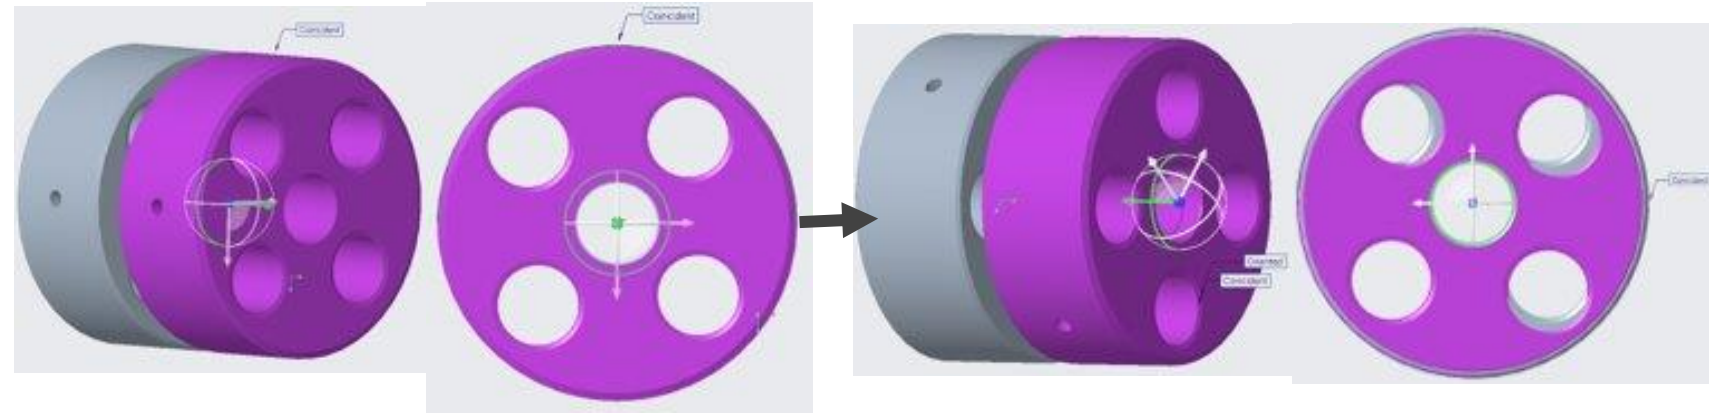
- System differences
 - Single-cam system idler shaft connected rigidly to block with press-fit dowel pin
 - Dual-cam system idler shaft and mounting spacer not rigidly connected to block
 - Dual-cam idler shaft cannot be rigidly connected, needs to adjust for lash, so ensure single-cam idler shaft is not fitted with a dowel pin for this application
- No idler shaft design differences are significant to its fit within system
- Single-cam idler shaft can therefore replace current dual-cam idler shaft
 - No design changes necessary
 - Compatible with current dual-cam mounting spacer
 - Rotate single-cam idler shaft 90 degrees clockwise to fit to dual-cam system
- No need to replace mounting spacer
- All other components are common between systems

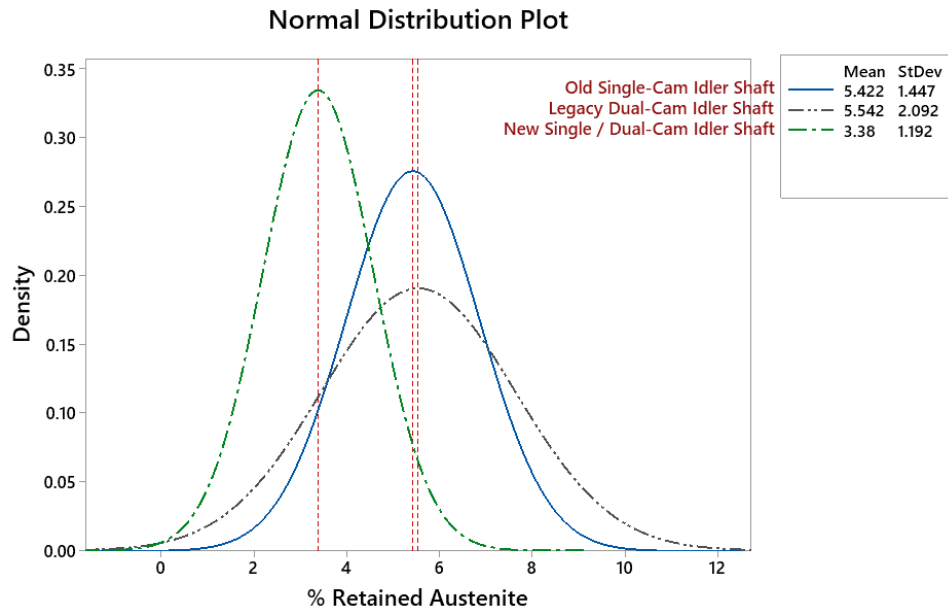
Dual-Cam System Solution Effective Rate

- Old single-cam idler shaft avg RA = 5.422% Std dev = 1.447
- Legacy dual-cam idler shaft avg RA = 5.542% Std dev = 2.092
- **New single-cam idler shaft** avg RA = 3.380% Std dev = 1.192
 - 37.7% reduction in retained austenite from old single-cam idler shaft
 - 39.0% reduction in retained austenite from current dual-cam idler shaft

- Since these retained austenite reduction rates are approximately the same, we can assume about the same **19% reduction in radial growth** from the dual-cam idler shaft
- Radial growth reduction should correlate to reduction in failures
