# **JTC Engineering VPCR Response**

**Odin Breather Hose**

**Contacting Shutoff Valve  
on Intake Manifold**

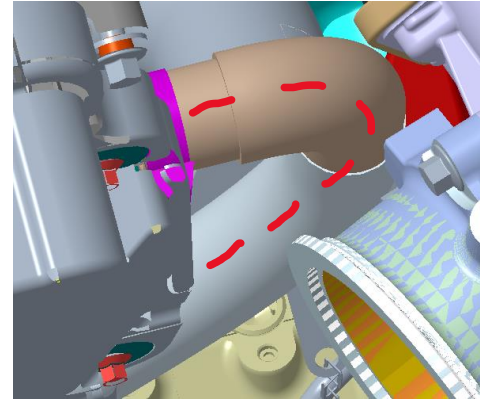
- Odin breather hose: 5348266
- Installed in final parts mounting repair area
- Shown without insulation, however insulation covers full length of hose
- Other engine configurations: 3688597
- Shorter breather hose model
- Insulation does not cover top section of hose

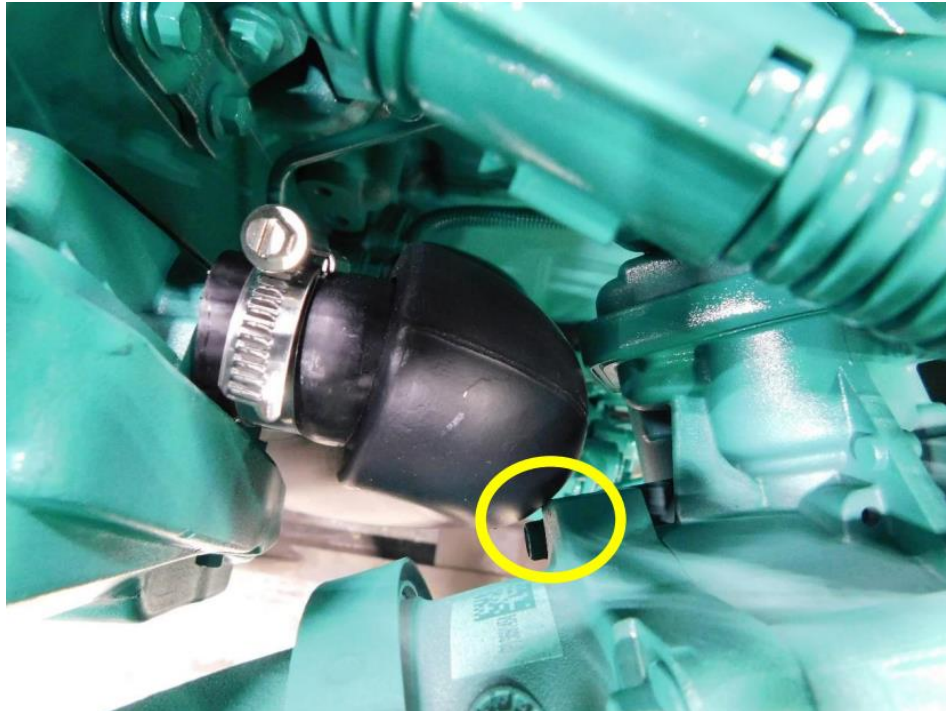
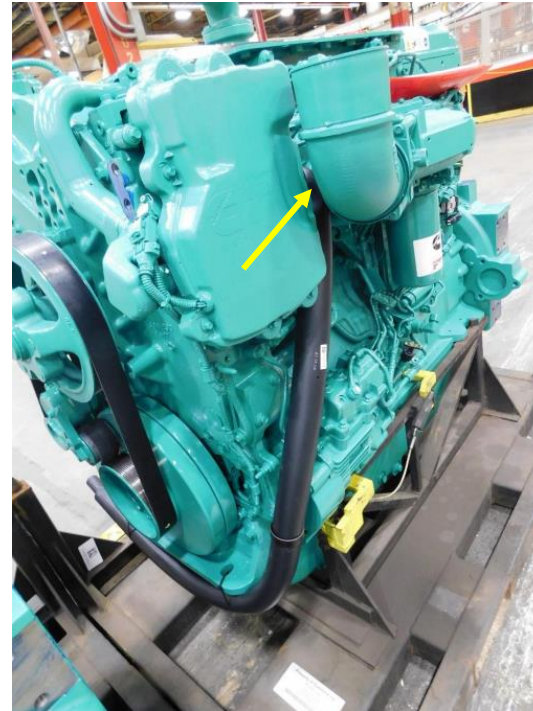
- Odin breather hose is difficult to install due to size and tight fit
- Insulation covering hose makes contact with the shutoff valve
- May create long-term wear on insulation and shutoff valve during operation

- Remove a section of insulation from top part of breather hose
  - Identify location where insulation makes contact with shutoff valve
  - Mark this location on hose
  - Mark how much insulation must be removed to prevent contact
- Engine heat is sufficient to prevent top section of breather hose from freezing without insulation
  - Insulation is unnecessary at the top of the breather hose, obsolete feature
  - Automotive hose demonstrates this
- Automotive breather hose (3688597) has no top insulation
  - Current insulated Odin hose (5348266) is longer than the automotive model
  - We cannot replace the Odin hose with the automotive model
- Must modify insulation for existing Odin breather hose

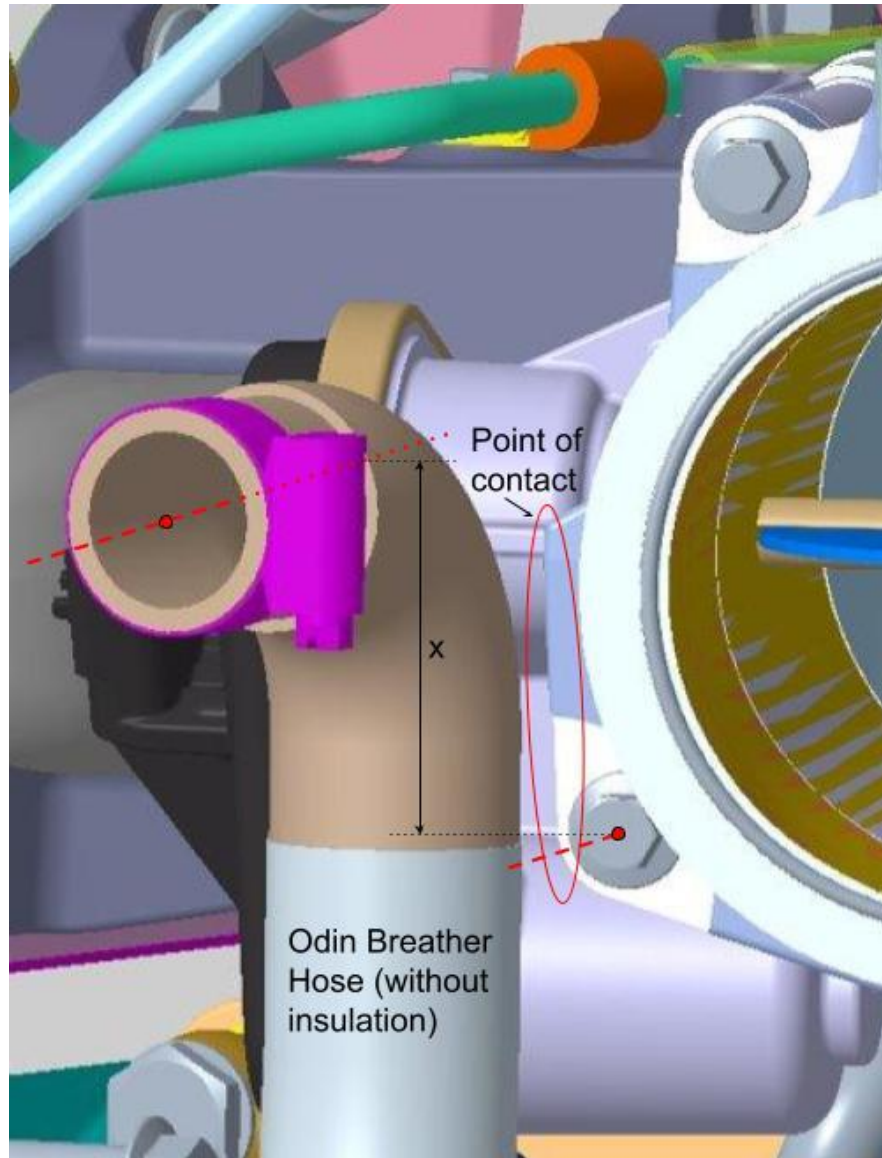
- Distance from top of hose centerline to lowest possible insulation contact point  $x = 47.7$  mm
- Insulating tube from the top of the hose must be removed so that there is no insulation above 47.7 mm from this centerline
- To allow for plenty of clearance, we should remove at least **75 mm** of insulation from the top hose centerline
