JTC Engineering Investigation

**Ring thrust bearing slips
behind idler shaft during
installation of FPIG**

By: Jessica Nicholson

Date Opened: 6/7/2021

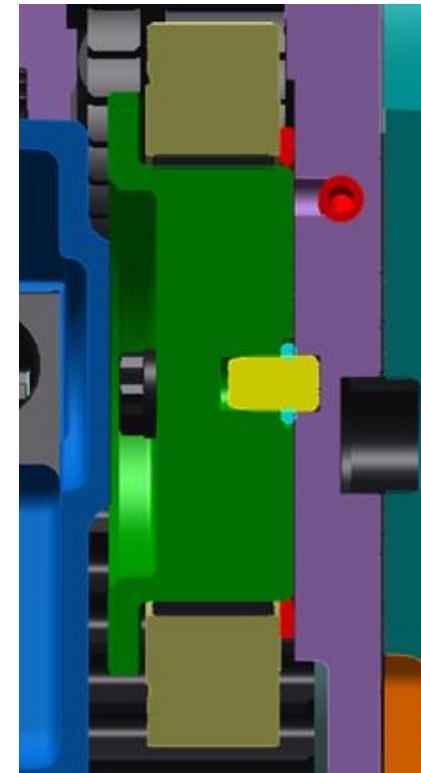
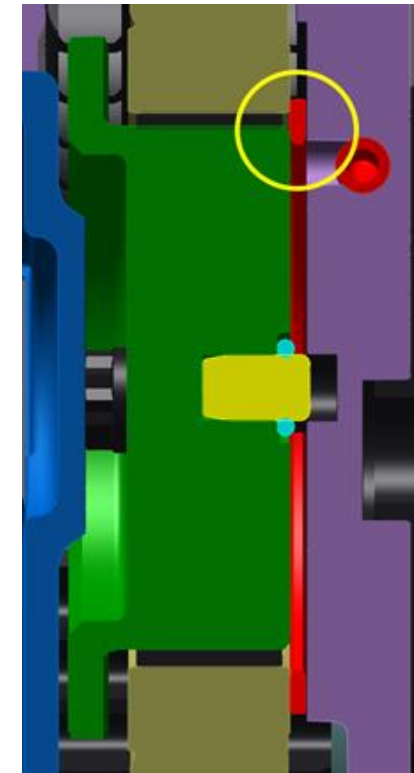
Correct Design
(section view)

Failed Design
(section view)

- **Fixed system fails**
- Thrust bearing slips behind FPIG idler shaft
- Slip occurs during installation
- Issue often goes unnoticed
 - Ring is thin
 - Changes in idler shaft position are difficult to visually identify
 - Ring is obscured by gear and idler shaft once installed
- Effects of failure
 - Idler shaft not fully connected by dowel pin, can misalign or detach
 - Efficiency loss and excess radial load occur
 - Gears fall out of mesh, short-term engine failure

- Prevent the ring thrust bearing from slipping during installation
- **Design a plate thrust bearing for the fixed system** to replace the ring
- Opportunity to commonize the thrust bearing for both the fixed and adjustable systems; new plate design that works for both systems
- Must redesign components of fixed system to accommodate plate
 - Both systems perform the same function, are similarly assembled
 - Adjustable system does not experience the same failure mode
 - Plate thrust bearing bolted into the housing with the idler shaft
 - Cannot slip out of place or misalign the idler shaft
 - Plate thrust bearing advantages
 - Cheaper by part than the ring thrust bearing (long-term savings)
 - Proven reliable, lower failure rate shown by ISX1 claims data

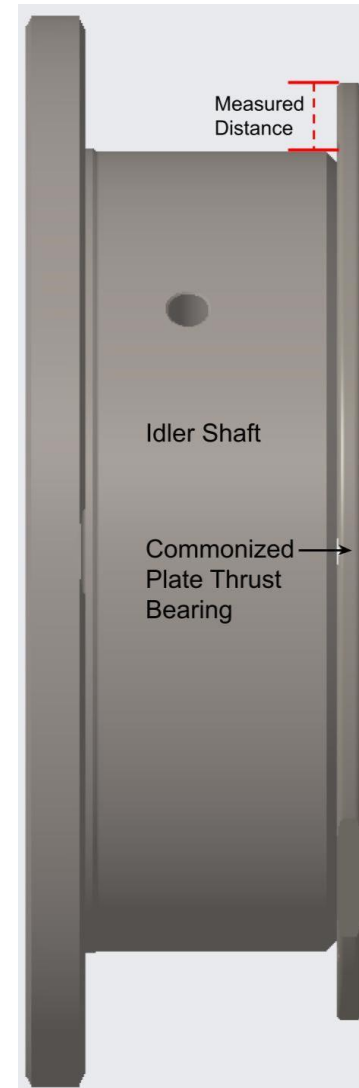
- Larger cap screw holes in commonized thrust bearing
 - More slop in both systems
 - Center axes can become more offset during installation
- Center axes of idler shaft and thrust bearing must align
- Misalignment may lead to long-term issues
- Measured the edge in this figure assuming greatest possible offset / misalignment
 - Fixed system
 - Adjustable system
 - Adjustable system with original thrust bearing, for comparison

- Full table of results in Appendix
- DVA measurements of each system at critical edge:
 - Each aligned system: 6.07 mm +/- 0.1901
 - Narrow edge of the fixed system, misaligned: 5.07 mm +/- 0.4404
 - Narrow edge of the adjustable system, misaligned: 2.94 mm +/- 0.4185
 - Narrow edge of the original adjustable system, misaligned: 3.96 mm +/- 0.4185
- Magnitude of misalignment must not allow thrust bearing to lose contact with the idler gear as the bushing would be exposed and leak oil
- Additional calculation using worst-case thrust bearing misalignment
 - Added clearance between gear + bushing inner diameter and idler shaft
 - Max distance from thrust bearing edge to inner gear edge: **0.958 mm +/- 0.4241**
- ⑩ **No significant risk** of failure due to leakage from misalignment

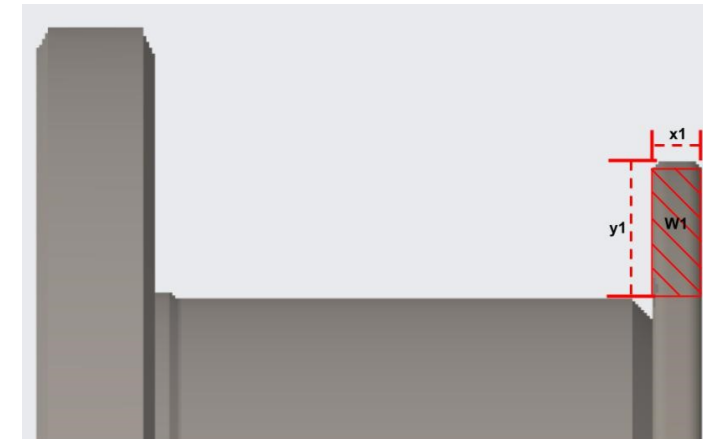
- Idler gear contacts thrust bearing during operation
- Large enough misalignment may create uneven friction wear
- Maximum misalignment measured by DVA tolerance analysis
- Friction wear formula: $W = KFVT = xy$, $W_1 = W_2$, $x_1y_1 = x_2y_2$
 - W = Volumetric wear, T = Elapsed time
 - K = Wear factor constant, same on both sides, same material
 - F = Normal force of the idler gear acting on the thrust bearing
 - V = Rotational velocity of idler gear against thrust bearing
 - x = Rate of wear, loss of material
 - When $y_1 < y_2$, $x_1 > x_2$ and $x_1 = ax_2$ (a = constant)

System Type and Configuration	Narrowest edge (y1) [mm]	Widest edge (y2) [mm]	a (y2/y1)	
All systems, aligned	6.07	6.07	1.000	$x_1 = x_2$
Fixed, maximum misalignment	5.07	7.08	1.396	$x_1 = 1.396 x_2$
Adjustable, maximum misalignment	2.94	9.2	3.129	$x_1 = 3.129 x_2$
Original adjustable system, maximum misalignment	3.96	8.18	2.066	$x_1 = 2.066 x_2$

- System assumptions:
 - Normal force from idler gear remains constant on both sides
 - Material is constant in the thrust bearing
 - Rotational velocity from the idler gear is the same on all sides
- Theoretically, the narrowest edge of each system experiences "a" times as much wear as the widest edge of the system
- In practice, however, $W1$ is not always equal to $W2$
- The level of **wear on surface remains even** regardless of misalignment
 1. Wear due to friction starts to become greater on narrow edge of the thrust plate
 2. Normal force on the narrow edge becomes lower than that on the wider edge
 3. This lessens the rate of wear on the narrow side compared to the wider side
 4. Total wear due to friction on each edge evens out regardless of misalignment
