End of Co-op Presentation

By: Jessica Nicholson

Water Transfer Tube Weld Cracking Investigation

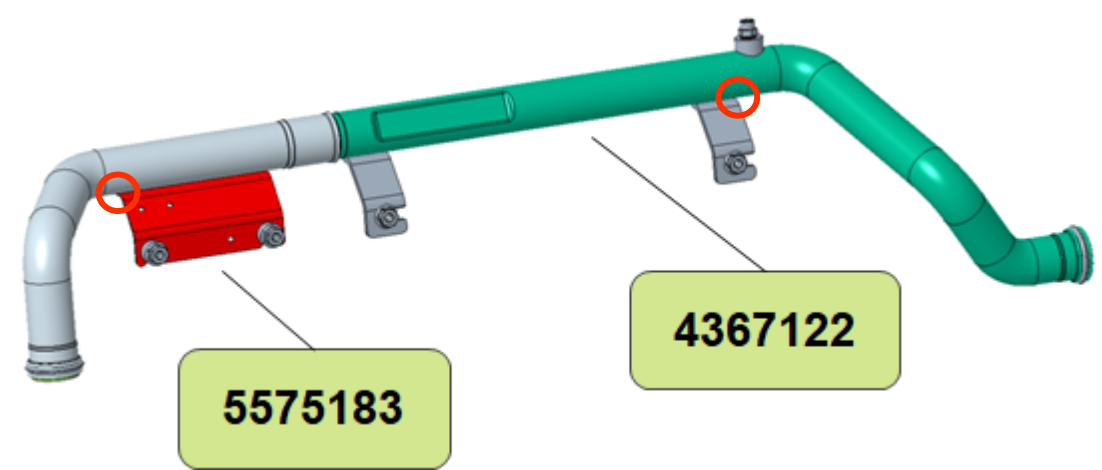
- Failure along circled weld joints
- Both tubes crack along weld joint connecting bracket to tube
- Crack can get worse and lead to coolant leak if not identified and fixed
- Many claims of cracked welds with leaking coolant

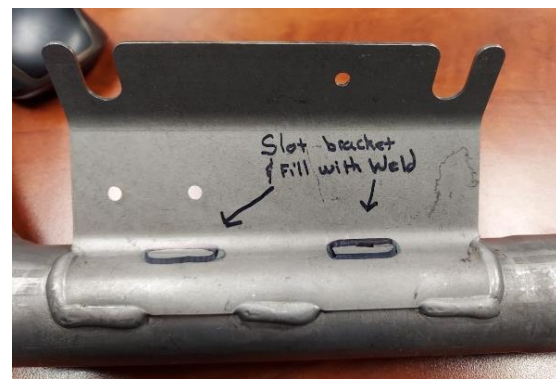
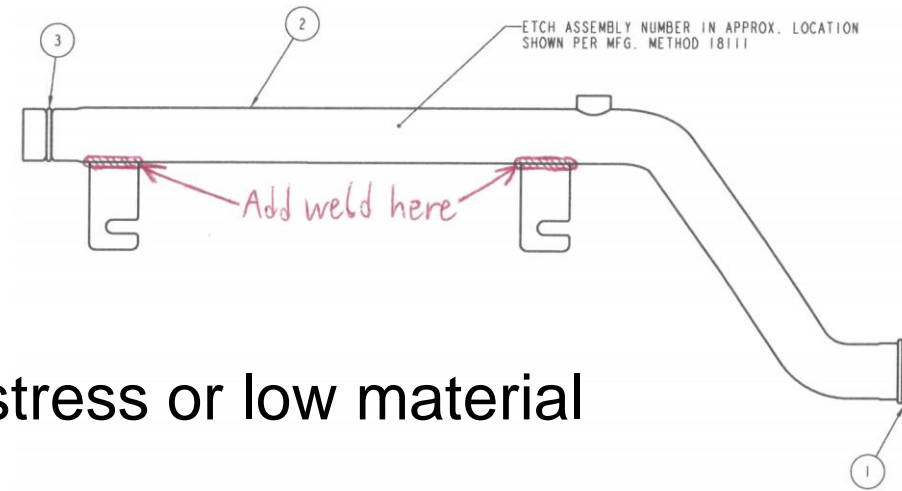
- Failure mode is most likely a form of excessive stress or low material strength due to quality issues
- Create additional welds behind each long tube bracket to secure to the pipe
- Create two 5/16" slot welds in the short tube bracket and add weld
- These temporary solutions will create a stronger joint to resist failure due to stress or low strength while I investigate the cause of the weld cracking

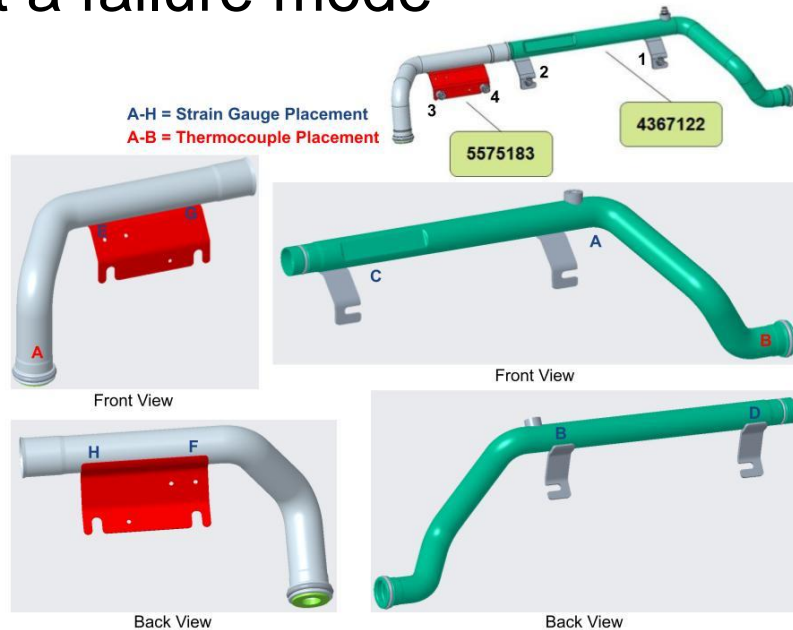
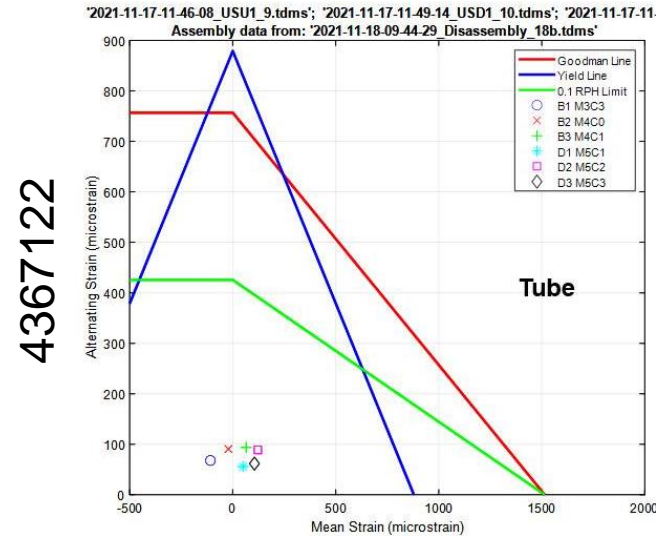
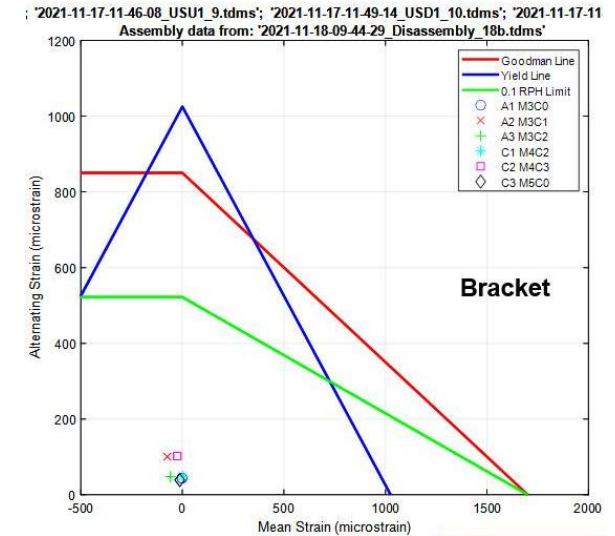
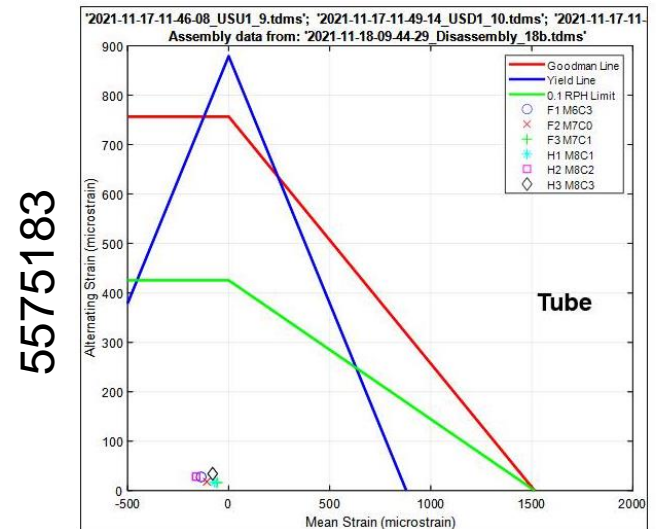
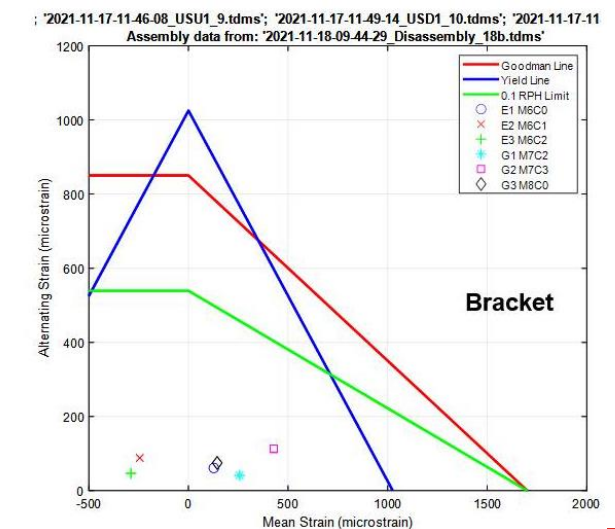
- Strain gauge engine operation
- Measured set of transfer tubes
- Static, mean, alternating stress
- Low + high idle, loaded, unloaded
- Not a failure mode

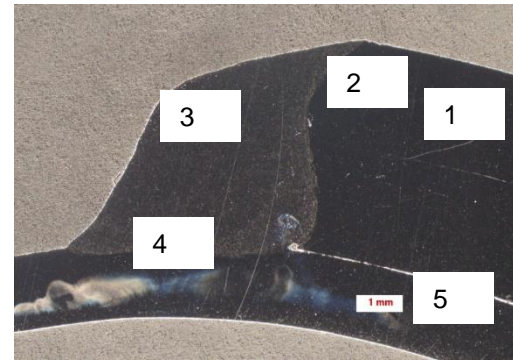
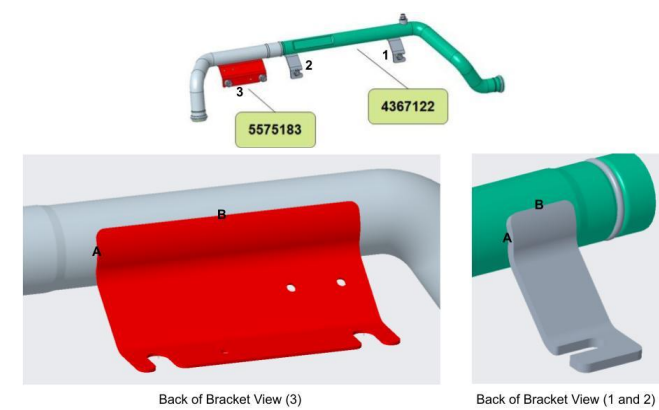
- High hardness leads to low ductility and low fracture toughness
- Hardness measured in multiple locations to ensure no welds exceed 350 HV
- No hardness measurements exceed this specified maximum
- Hardness expectedly increases at HAZ and weld, joints more susceptible
- Not a primary mode of failure, only a concern with high stress conditions

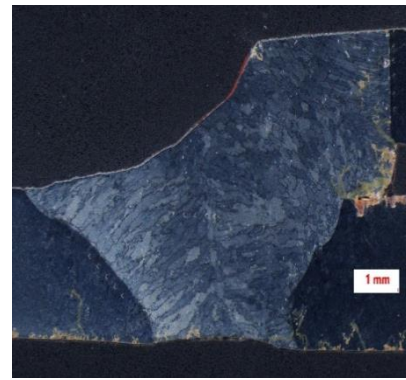
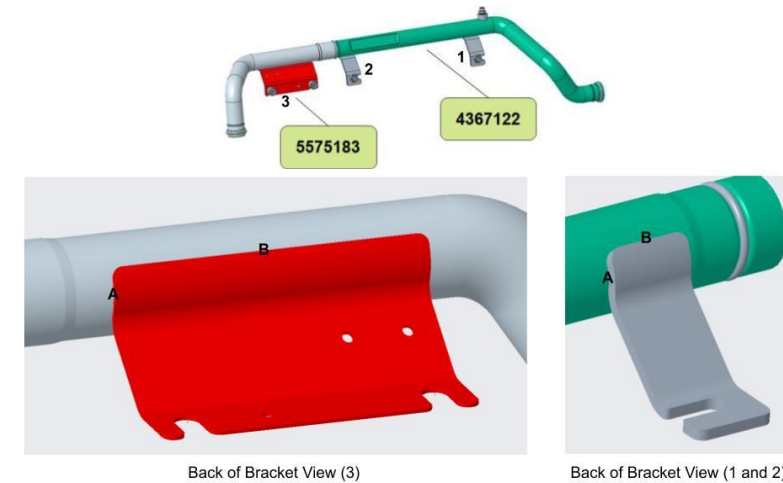
- Inspected weld properties in failed and new samples
 - ISO 5817 standards used to evaluate weld properties
 - Cross-section cut to evaluate each weld
- Evaluated properties: Throat size, porosity, penetration, root fusion
- Multiple imperfections found, **likely modes of failure**
 - Most welds on bracket 1 and 2 do not meet the minimum throat size, 3 mm
 - Root gaps of several welds exceed max limit of 0.6 mm for a 3 mm throat size
 - The larger the root gap, the smaller the area of fusion and the weaker the joint
 - Most welds exceed allowable porosity, 1.5%
 - Some welds have minimal weld penetration, only one critically inadequate weld
 - Clearance between bracket and pipe near weld that can weaken the joint
- Supplier quality issue; contacted suppliers to make changes in weld process

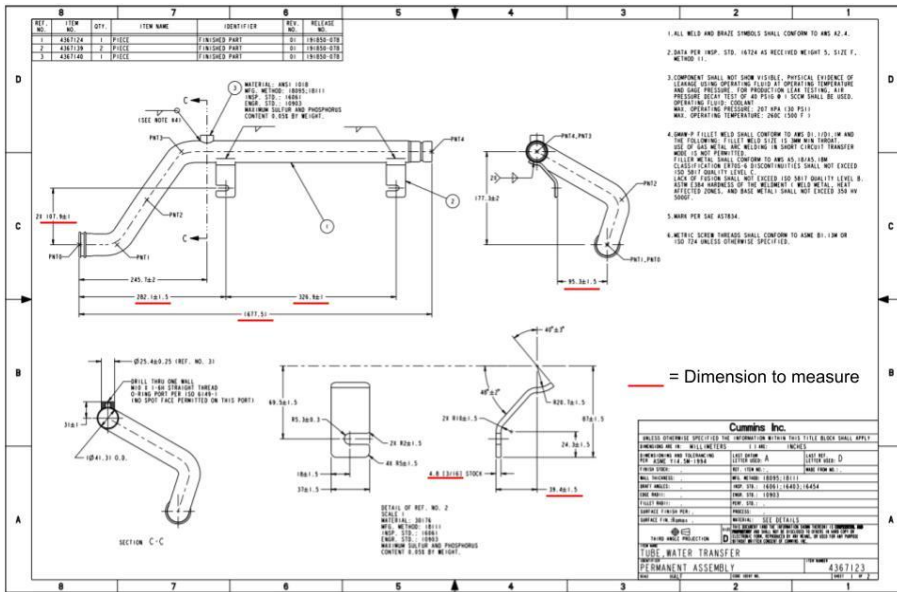
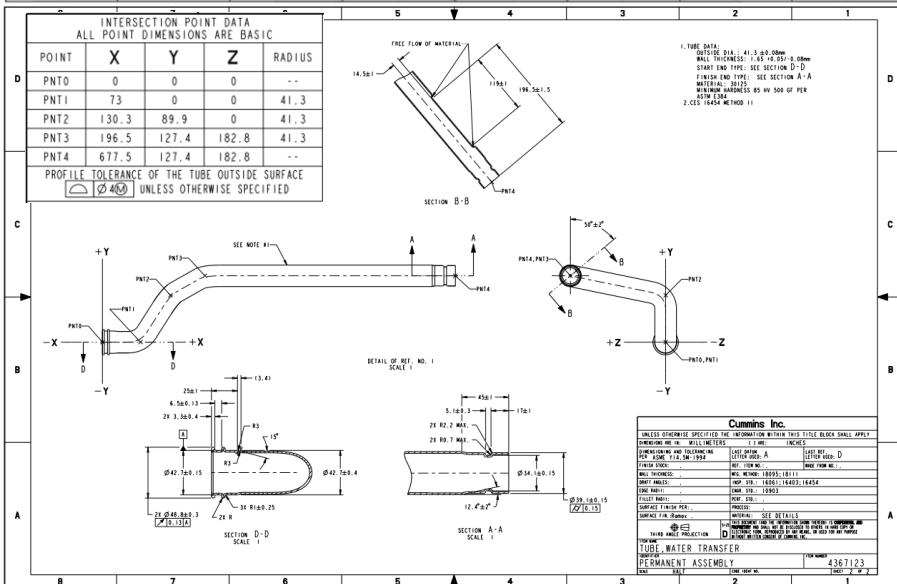
Dimensional Quality – Transfer Tube 4367122

- No dimensional variation greater than 0.5 mm between samples
- Some dimensions consistently deviate from print tolerance
- Failure due to excess static stress from:
 - Deviation at point 2 is **not** a failure mode
 - Point 2 position is not relevant to fit to the block
 - Deviation at point 4 x-direction is a **low-likelihood** failure mode
 - Point 4 position has a minimal effect on tube fit to the block
- Variation between parts is **not** a failure mode

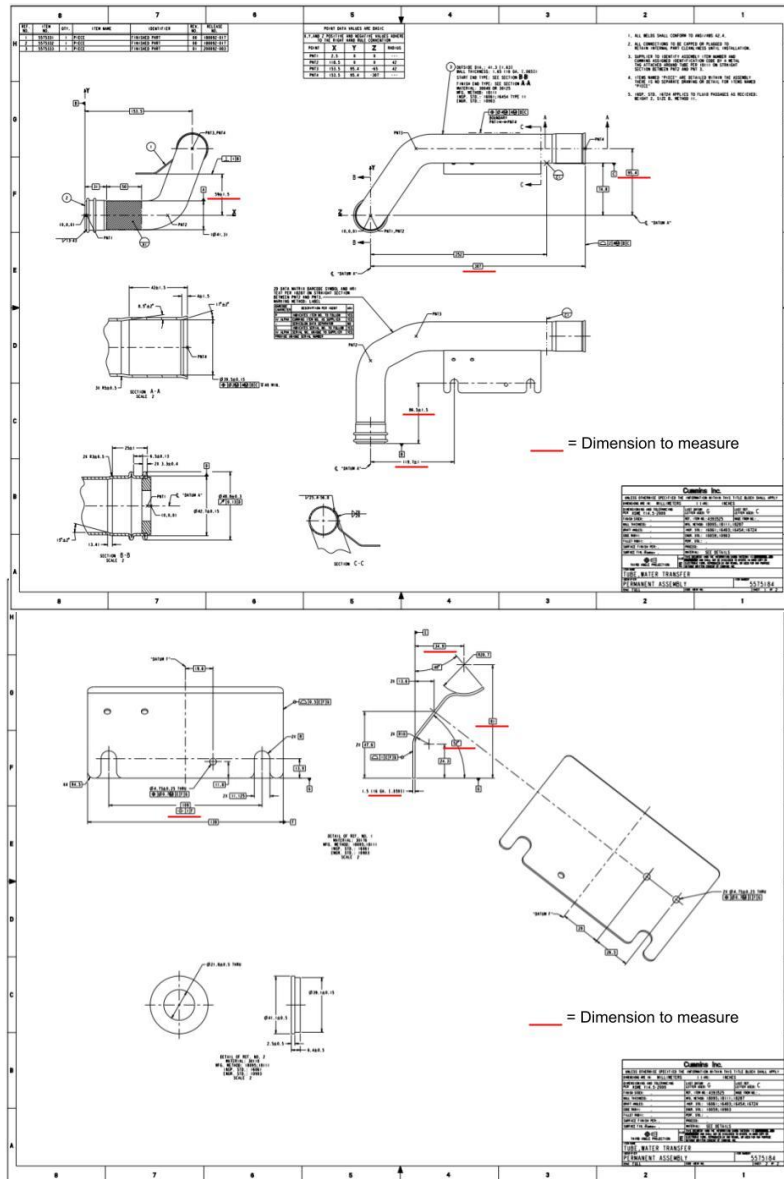
Dimensional Quality – Transfer Tube 5575183

- More dimensional variation than long tube, no greater than 3 mm
- Failed dimensions are not consistent, but many dimensions are out of tolerance
- Failure due to excess static stress from:
 - Deviation at point 4 is **low-likelihood**
 - Point 4 position has minor effect on fit
 - Incorrect bracket dimensions is a **low-likelihood** failure mode
 - Incorrect bracket position in any direction is a likely failure mode
 - Variation between parts is **low-likelihood**

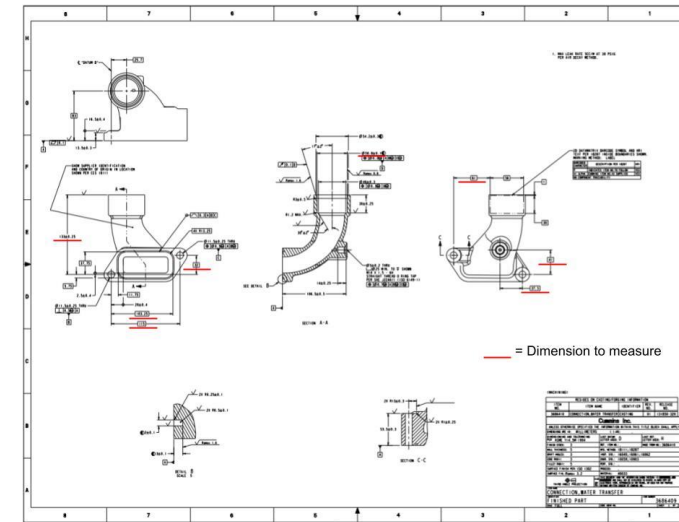
- Dimensional issues commonly found in these connectors
- 4 samples chosen with visually-evident machining errors
- Measurement failures with an impact on pipe fit and internal stress
 - Datum C position deviates in the x direction
 - Distance from datum B to end of tube fit variation
 - These dimensions have an impact on the x-direction fit of the connector
 - Datum D position variation
 - This position affects the horizontal x-y location that the pipe fits to the connector
 - Distance from datum B to top of connector
 - If this dimension is too long, it may push pipe upward (z-direction)
- These dimensional errors found in the 3686409 connector **are** a likely cause of failure due to internal stress caused by imperfect fit

- Connector supplier: Mahabal Metals
- 3 hydraulic and 1 manual clamping mechanism in each CNC machine
- Manual clamping mechanism identified as cause of dimensional issues
- Replaced manual clamping mechanism with hydraulic clamping mechanism
- Should significantly reduce error in positioning from manual mechanism

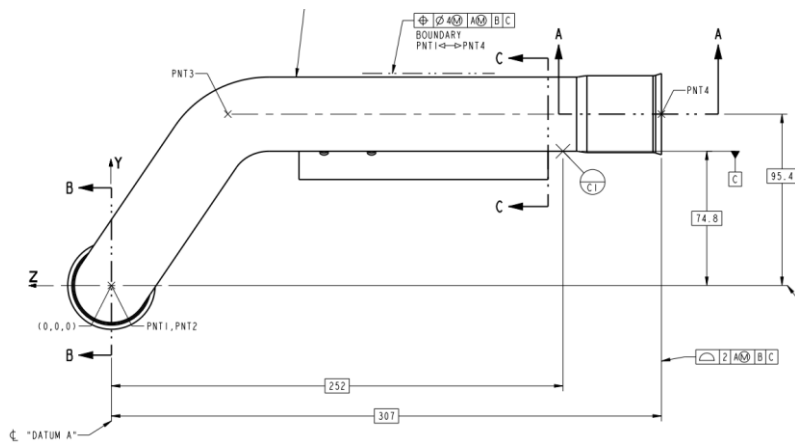
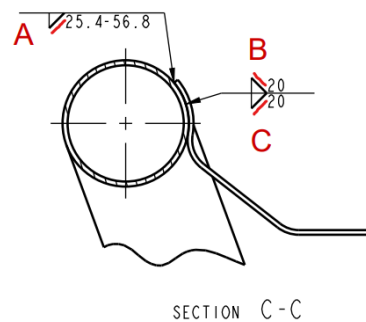
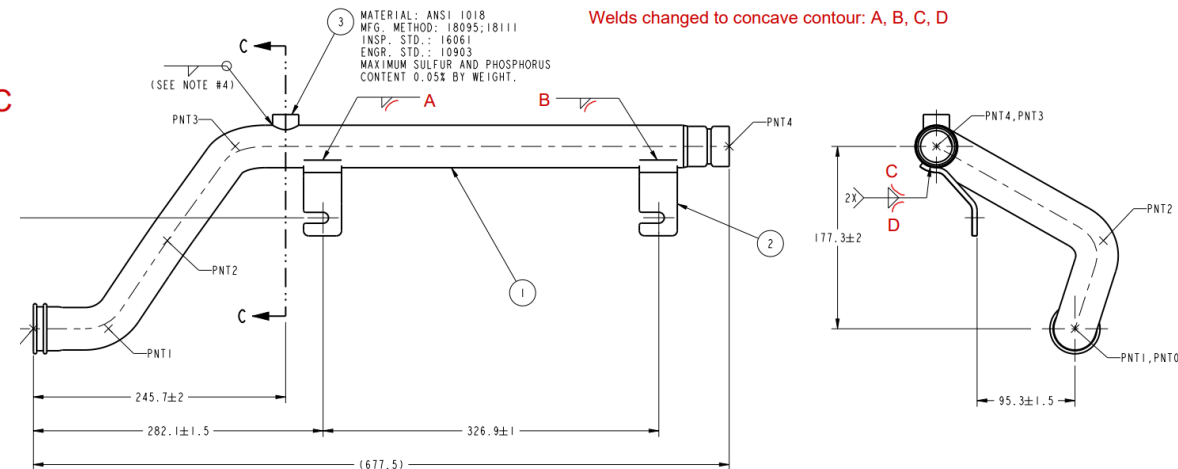
Welds changed to flat contour: A,B,C

- Weld geometry is currently unspecified on both transfer tube prints
 - Reflected by inconsistent welds seen on new and failed samples
- Add weld geometry specifications to each tube based on ANSYS analysis
 - Determined the best weld geometry to reduce stress concentration (slide #_)
 - Short tube weld contour: Flat weld
 - Long tube weld contour: Concave weld

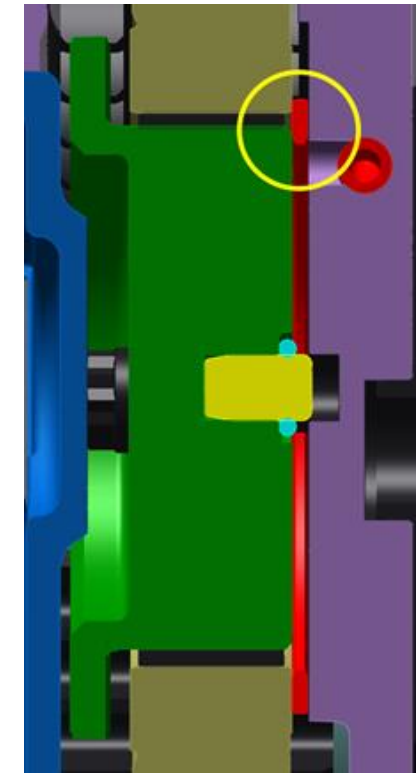
Failed Design
(section view)

- **Fixed system fails**
- Thrust bearing slips behind FPIG idler shaft
- Slip occurs during installation
- Issue often goes unnoticed
 - Ring is thin
 - Changes in idler shaft position are difficult to visually identify
 - Ring is obscured by gear and idler shaft once installed
- Effects of failure
 - Idler shaft not fully connected by dowel pin, can misalign or detach
 - Efficiency loss and excess radial load occur
 - Gears fall out of mesh, short-term engine failure

- Prevent the ring thrust bearing from slipping during installation
- **Design a plate thrust bearing for the fixed system** to replace the ring
- Opportunity to commonize the thrust bearing for both the fixed and adjustable systems; new plate design that works for both systems
- Must redesign components of fixed system to accommodate plate
 - Both systems perform the same function, are similarly assembled
 - Adjustable system does not experience the same failure mode
 - Plate thrust bearing bolted into the housing with the idler shaft
 - Cannot slip out of place or misalign the idler shaft
 - Plate thrust bearing advantages
 - Cheaper by part than the ring thrust bearing (long-term savings)
 - Proven reliable, lower failure rate shown by ISX1 claims data

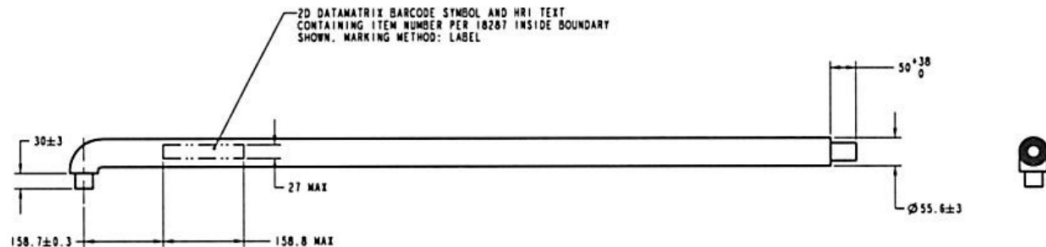
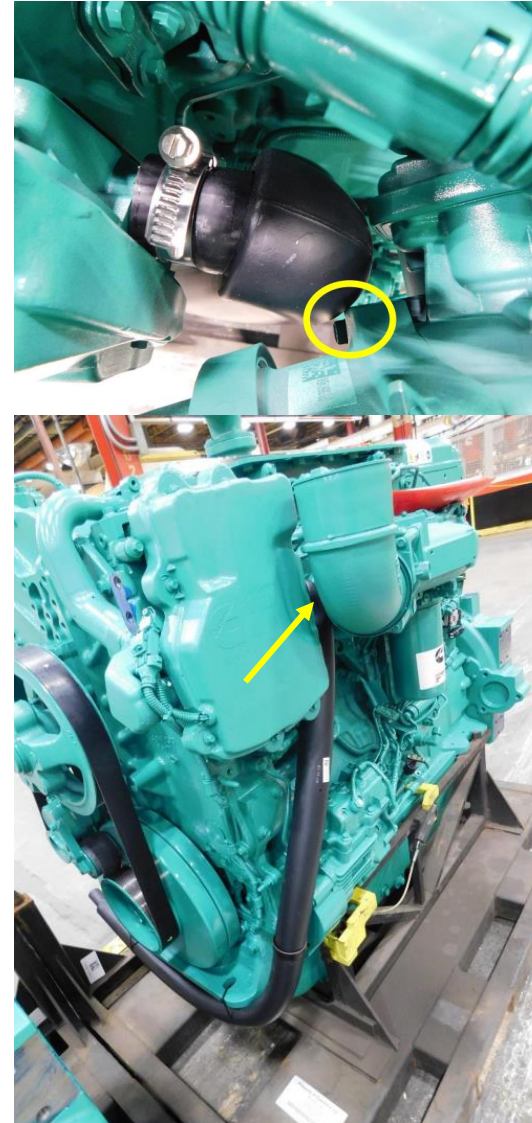
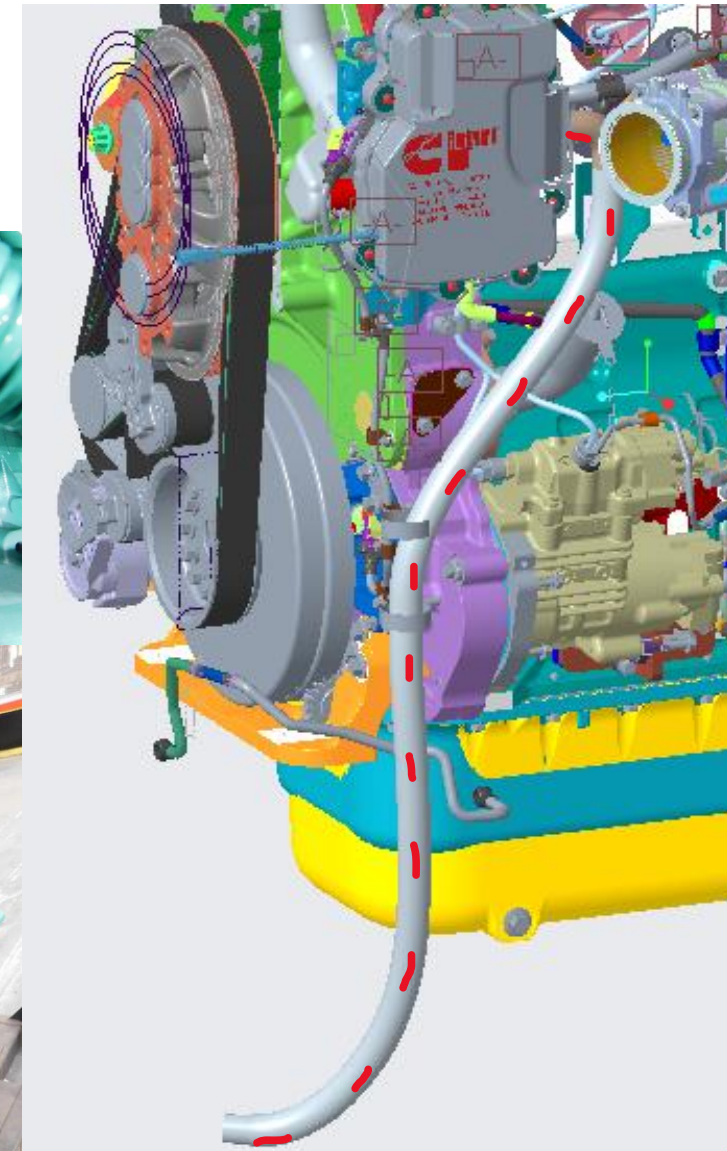
- Odin breather hose (5348266) is difficult to install due to size and fit
- Insulation covers full length of hose and makes contact with the shutoff valve
- May create long-term wear on insulation and shutoff valve during operation

- Remove a section of insulation from top part of breather hose
 - Identify point of interference / contact and determine insulation removal needed
- Engine heat is sufficient to prevent top section of breather hose from freezing without insulation
 - Insulation at the top of the breather hose is due to supplier design
 - Automotive hose (3688597) previously used in the Odin engine has a significant top portion with no insulation and no freezing issue claims
- Current insulated Odin hose (5348266) was implemented due to better fit as a longer hose than the automotive model
 - We cannot re-implement the automotive model, must modify existing hose
- The fit of insulation to the tube has no clearance, will remain secure if any insulation is removed

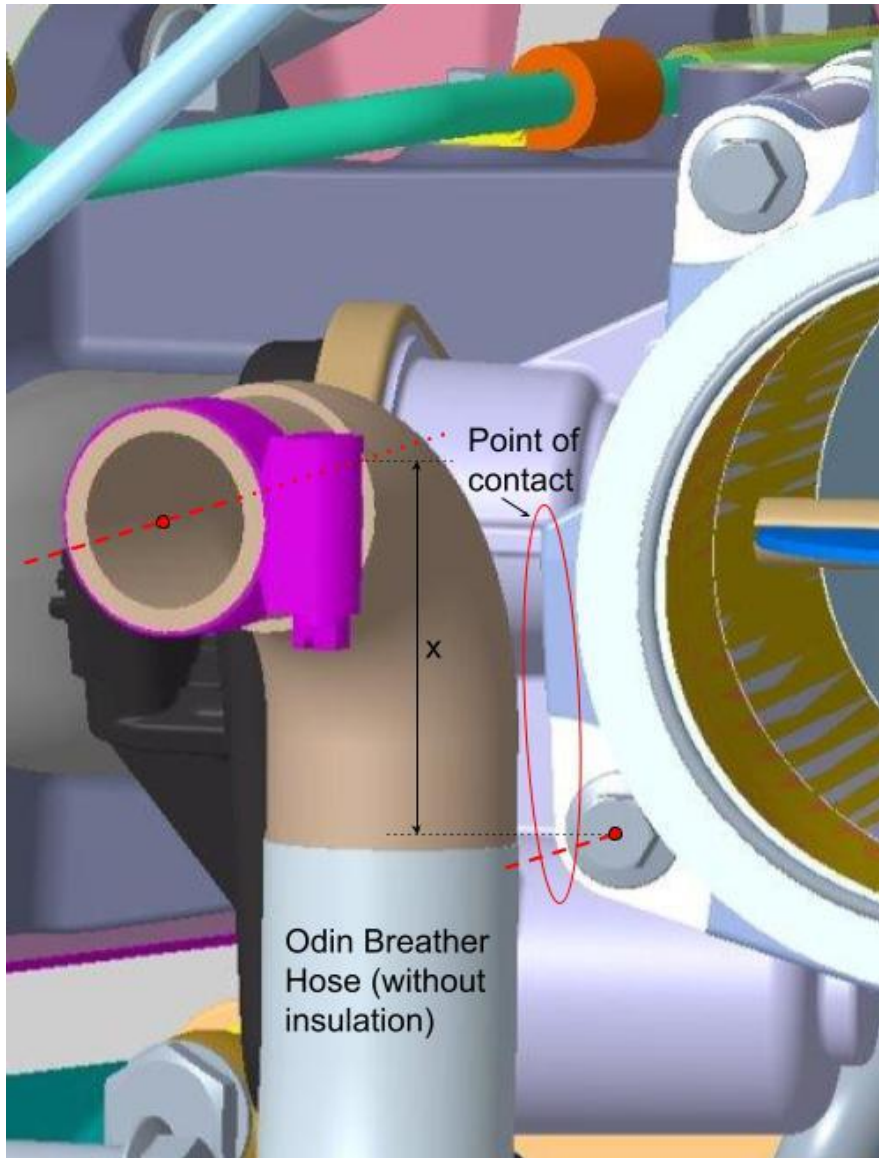
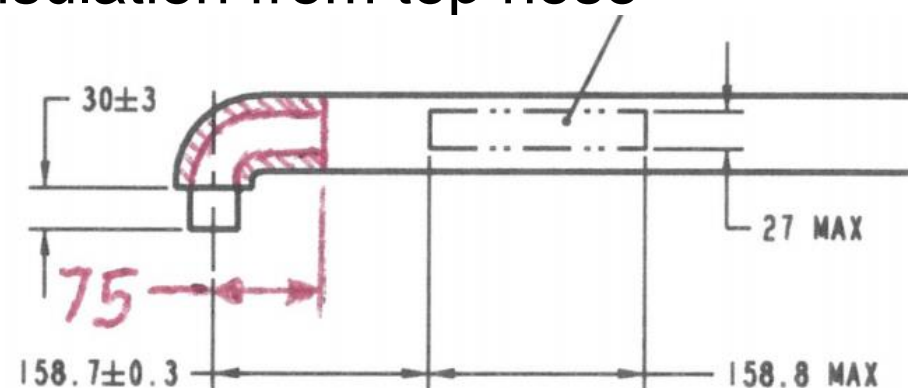
- Distance from top of hose centerline to lowest possible insulation contact point $x = 47.7$ mm
- Insulating tube from the top of the hose must be removed so that there is no insulation above 47.7 mm from this centerline
- To allow for plenty of clearance, remove at least **75 mm** of insulation from top hose centerline

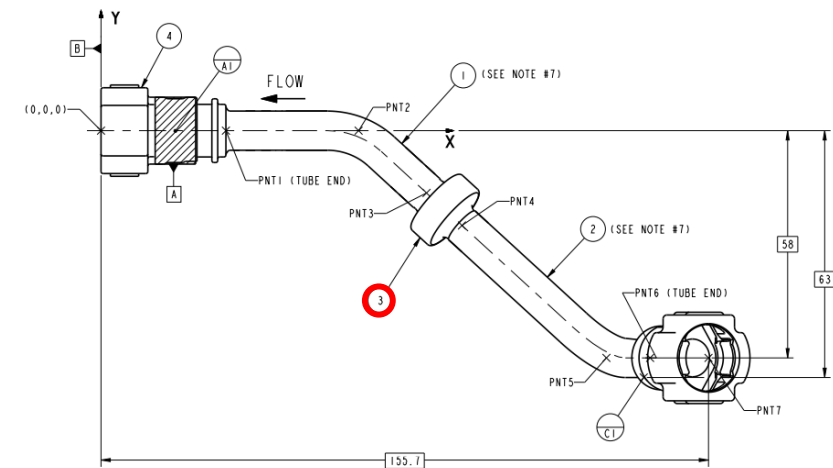
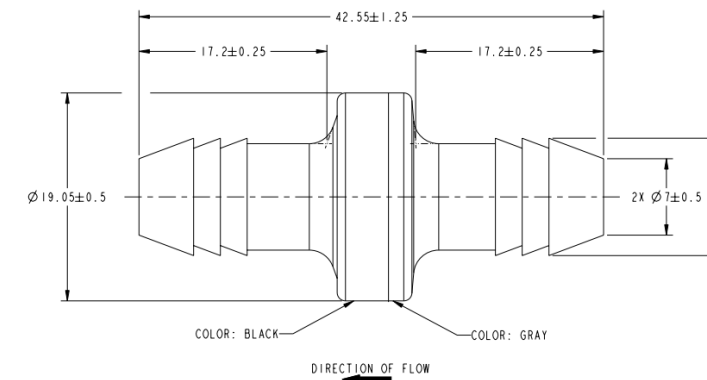
- ISX12N system oil drain tube (4399782)
- Check valve (5272318) controls direction of flow with internal membrane
 - Controls direction of oil flow
 - Membrane inside valve opens for flow
- Oil flows from the oil pan into the turbocharger and CAC
 - Check valve fails to control oil flow in correct direction
 - Some drain tubes are assembled in the wrong direction, causing a backwards check valve
 - This failure can damage both the turbocharger and CAC
 - Oil pressure loss and oil found on other components
- Drain tube is brittle, breaks, and experiences leaks
 - Internal system temperature exceeds material specs

- Mark drain tube connectors to indicate direction of flow
 - This will prevent drain tubes from being installed backwards
- Choose new check valve
 - Must handle negative pressure values due to turbocharger
 - Must withstand internal pressure range, check valves found broken
 - Must open to allow flow at the correct amount of pressure and close when pressure drops below this value
 - Compare specs of potential check valves with drain tube operating conditions
- Choose new tube material that can withstand greater temperature range
 - Use more heat-resistant material, must retain its ductility over time
 - Must not be prone to phase changes from long-term temperature fluctuations
 - Consider systems run at higher temperature than specs with high duty cycle

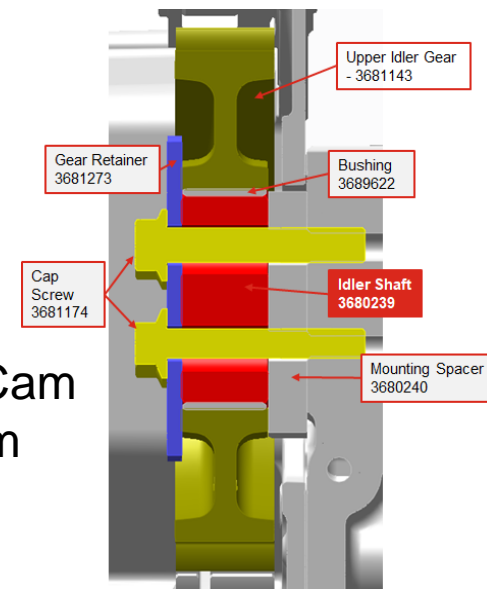
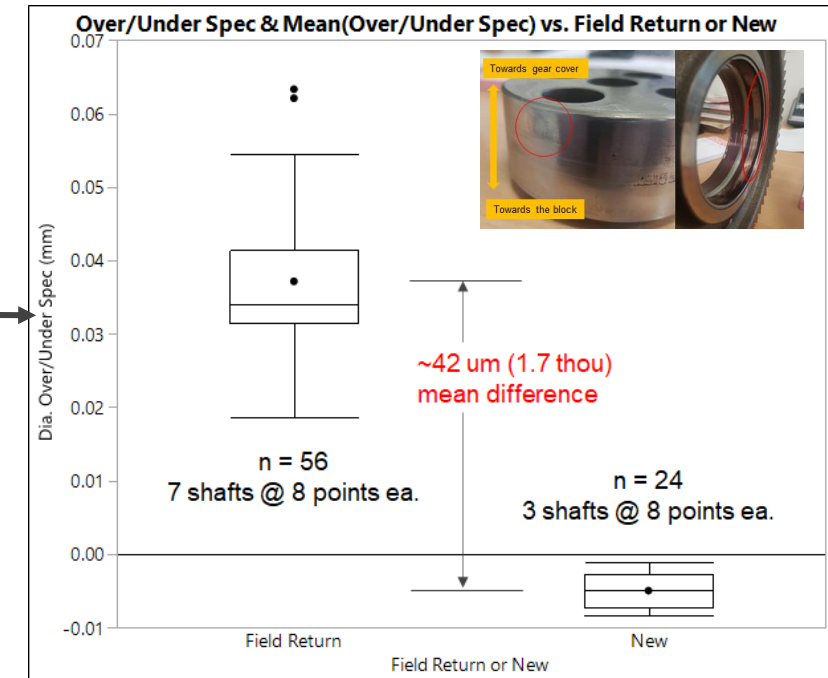
Dual-Cam System

- Retained austenite within dual-cam UIG idler shaft transitions into martensite over time with preload applied to bolts
 - Martensite formation causes diameter increase
 - Clearance between idler shaft and bushing narrows
 - Hydrostatic oil film narrows and eventually closes
 - Lack of oil film causes system failure
- Field return vs new part diameter measurements
- Heat treatment procedure altered for single-cam system to decrease retained austenite
 - Original = 350 F – 90 mins, New = 400 F – 90 mins
 - CTR 4120261 – 19% radial growth decrease

- **Replace dual-cam idler shaft** with the single-cam system UIG idler shaft
- Will prevent the dual-cam UIG idler shaft from generating martensite
- Apply change as a service part replacement, not production
 - Commonized UIG idler shaft for both systems in service
- Geometry and compatibility of both idler shafts
 - No need to redesign single-cam idler shaft or dual-cam system components
