JTC Engineering Investigation Upper Idler Gear Idler Shaft Expanding from Martensite Formation

By: Jessica Nicholson

Date Opened: 09/24/2021

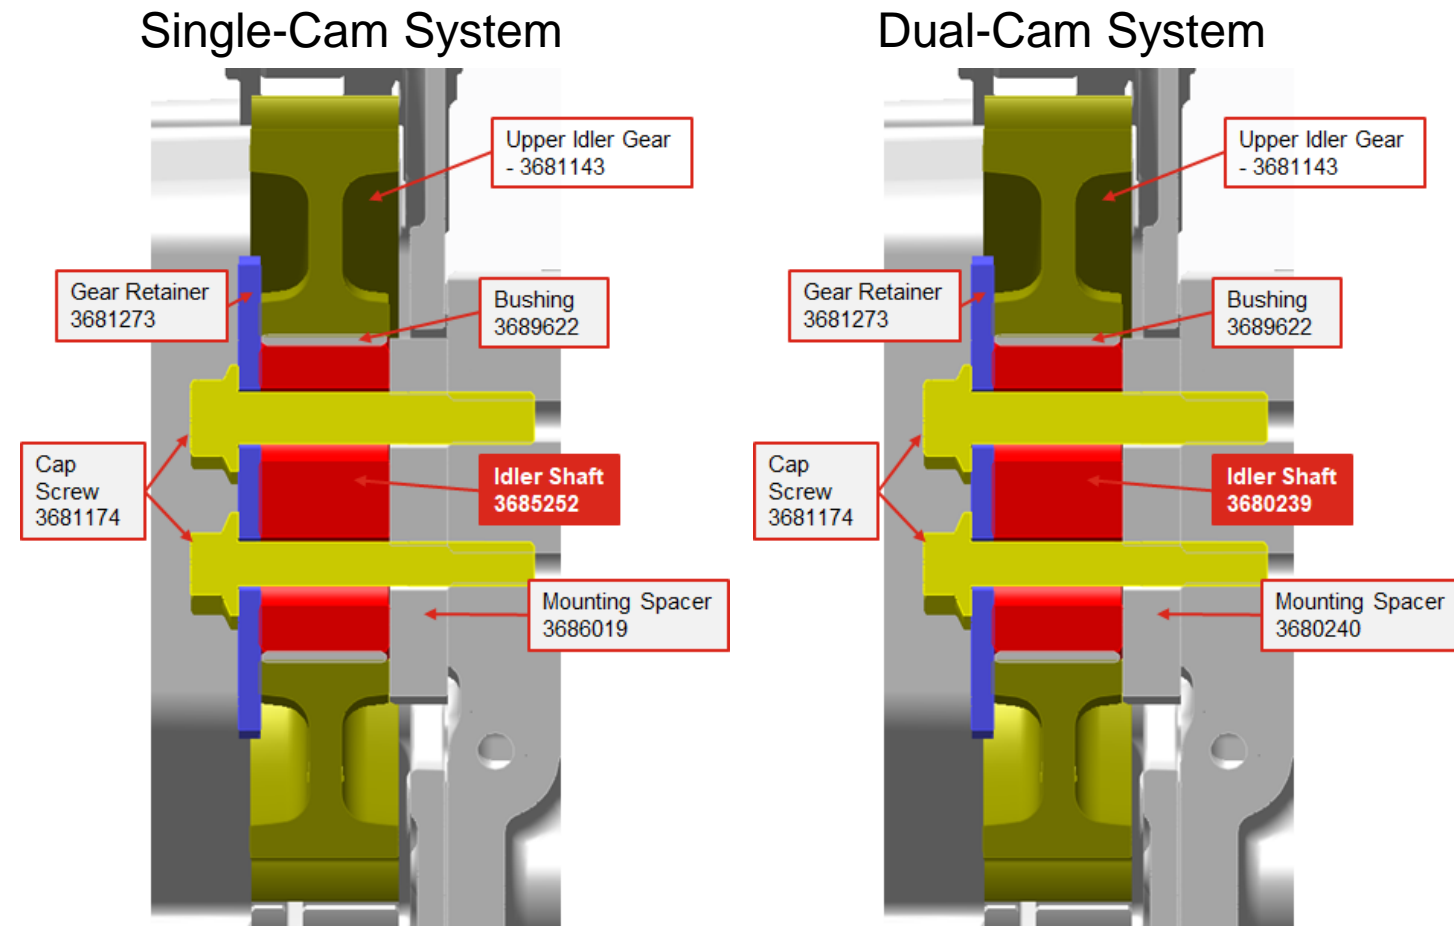
Single-Cam vs Dual-Cam Upper Idler Gear

- Current single-cam engines and older dual-cam engines have similar UIG systems
- Single-cam system
 - Idler shaft: 3685252
 - Mounting spacer: 3686019
 - Assembly: bb 1958
- Dual-cam system
 - Idler shaft: 3680239
 - Mounting spacer: 3680239
 - Assembly: bb 1902
- All other parts are common
