# **JTC Engineering VPCR Response**

**Odin Breather Hose**

**Contacting Shutoff Valve  
on Intake Manifold**

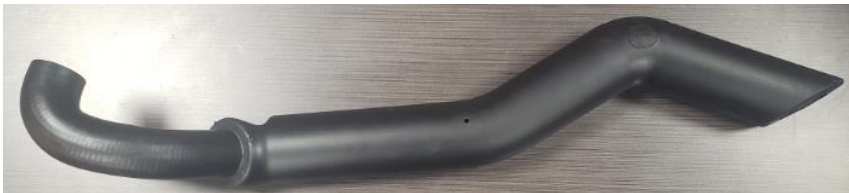
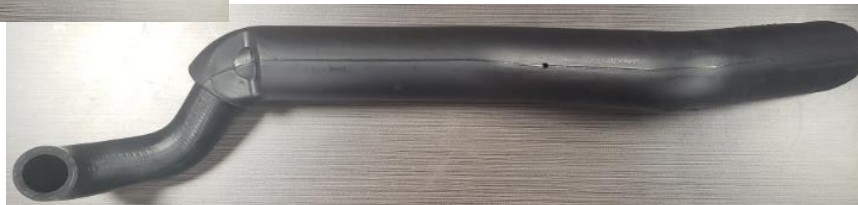
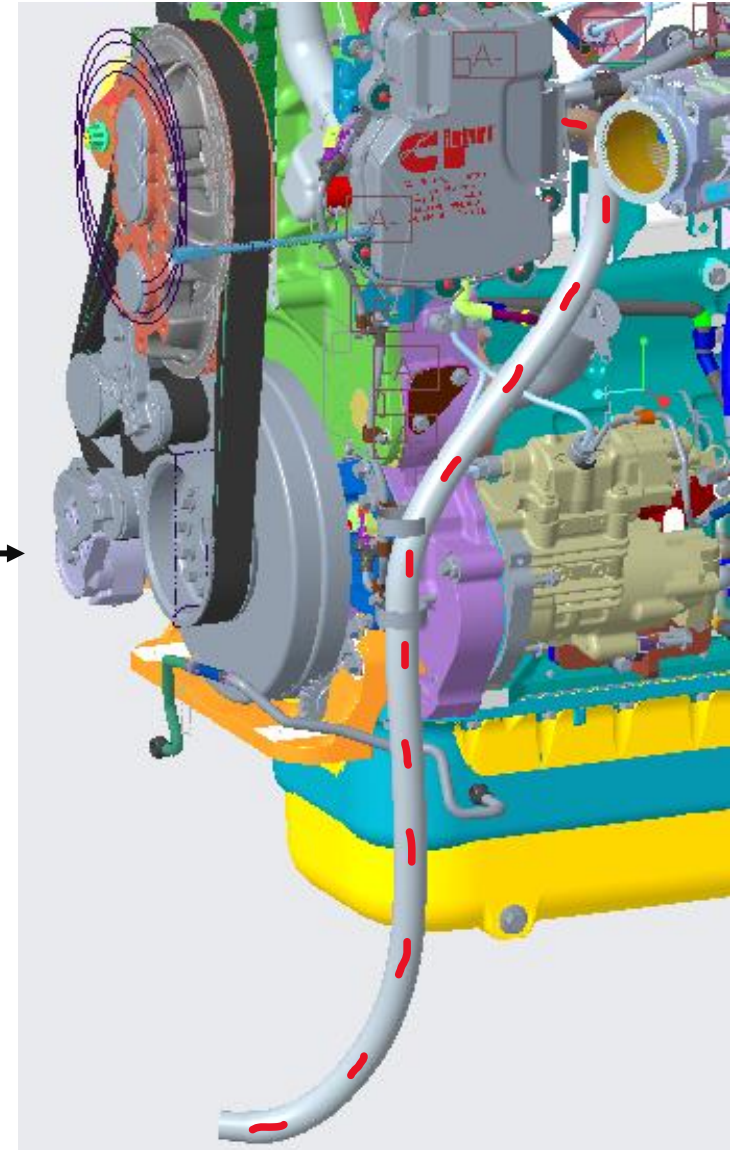
- Odin breather hose: 5348266
- Installed in final parts mounting repair area
- Shown without insulation, however insulation covers full length of hose
- Other engine configurations: 3688597
- Shorter breather hose model
- Insulation does not cover top section of hose
