JTC Engineering Investigation

**Ring thrust bearing slips
behind idler shaft during
installation of FPIG**

By: Jessica Nicholson

Date Opened: 6/7/2021

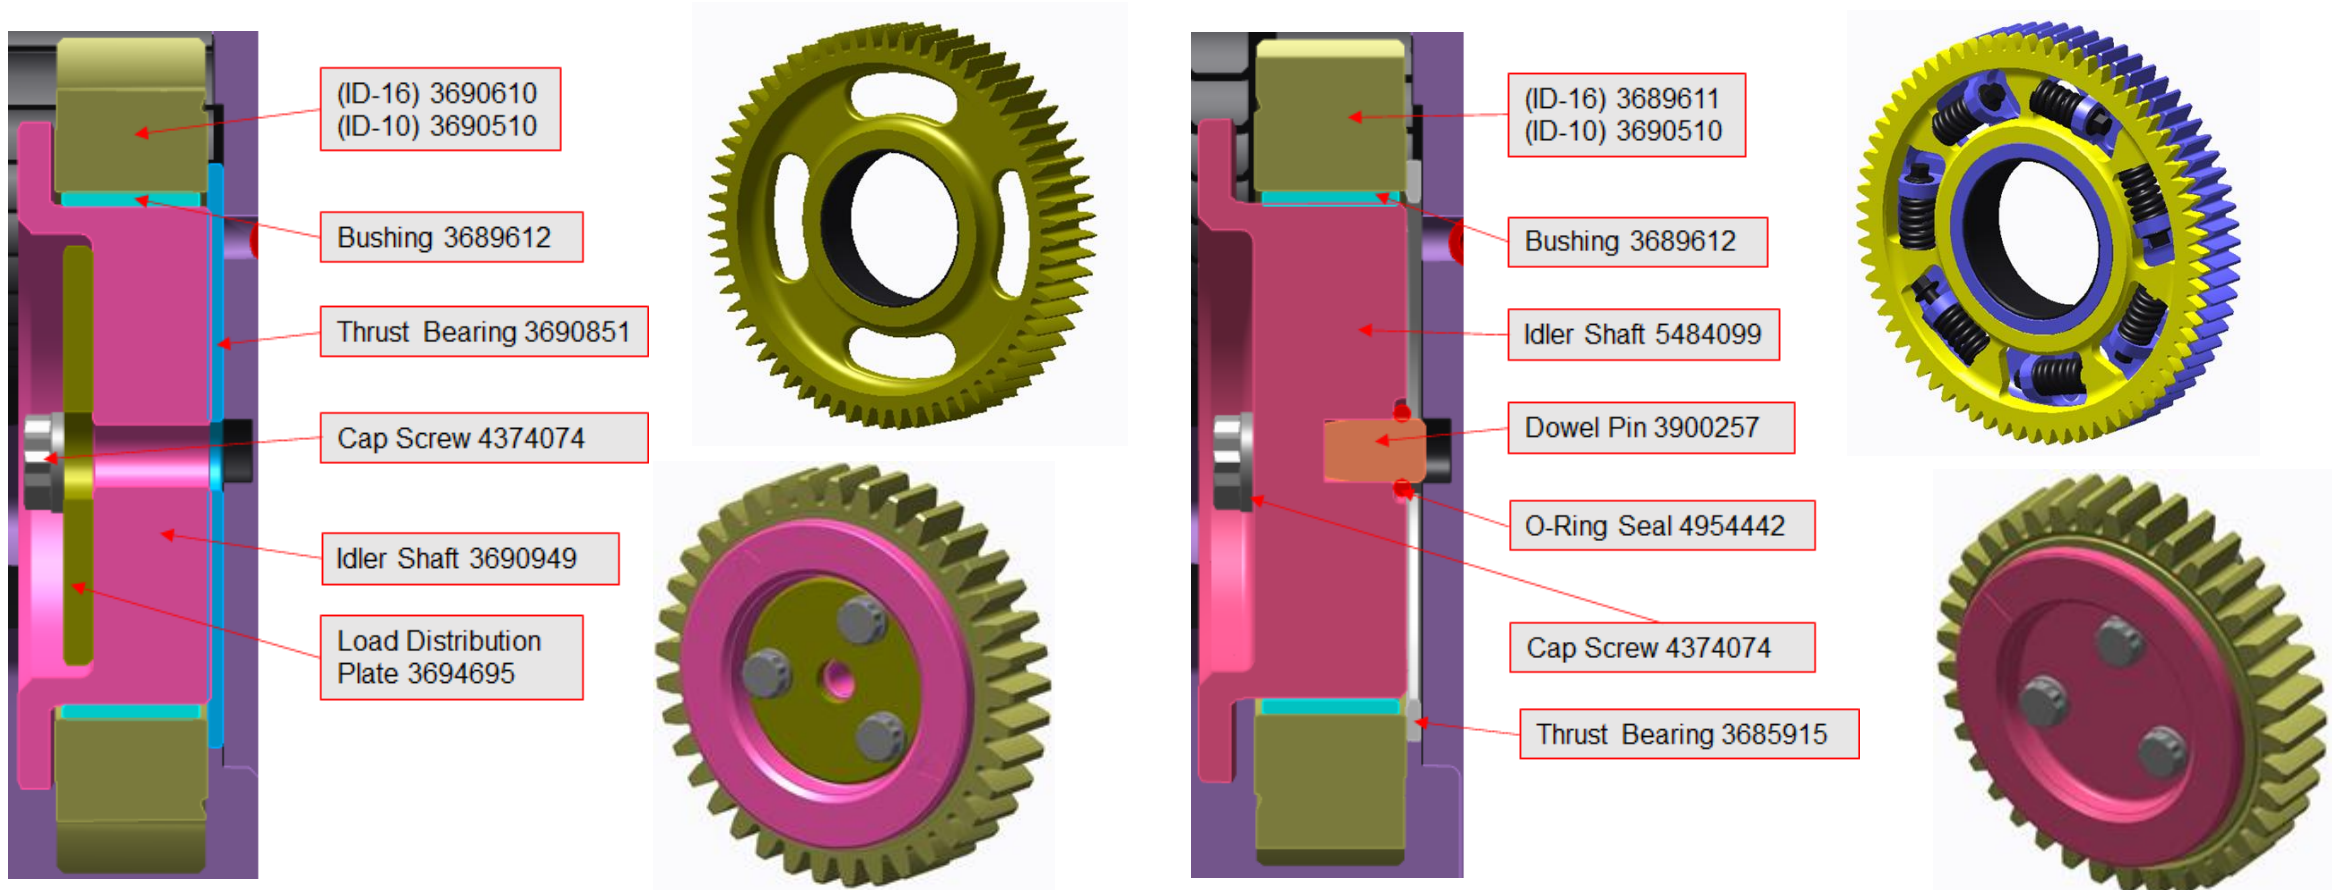
Adjustable vs Fixed Fuel Pump Idler Gear

Adjustable: Plate thrust bearing

- Solid driving gear
- Distribution plate to adjust

Fixed: Ring thrust bearing

- Scissor driving gear
- No adjustment for lash

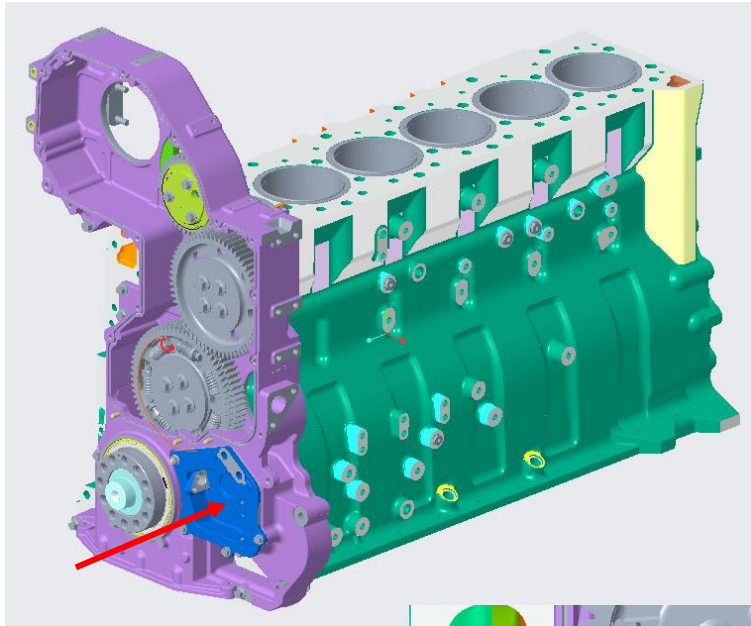
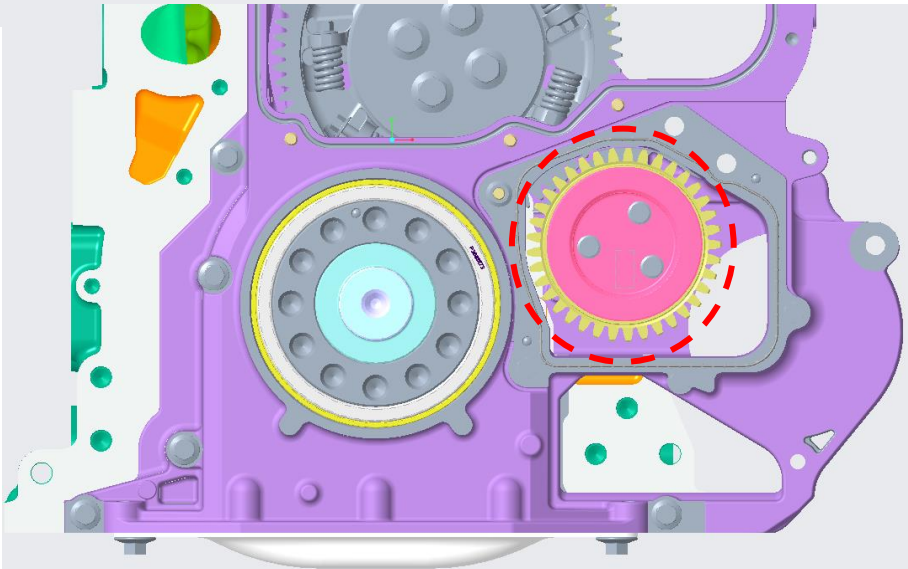
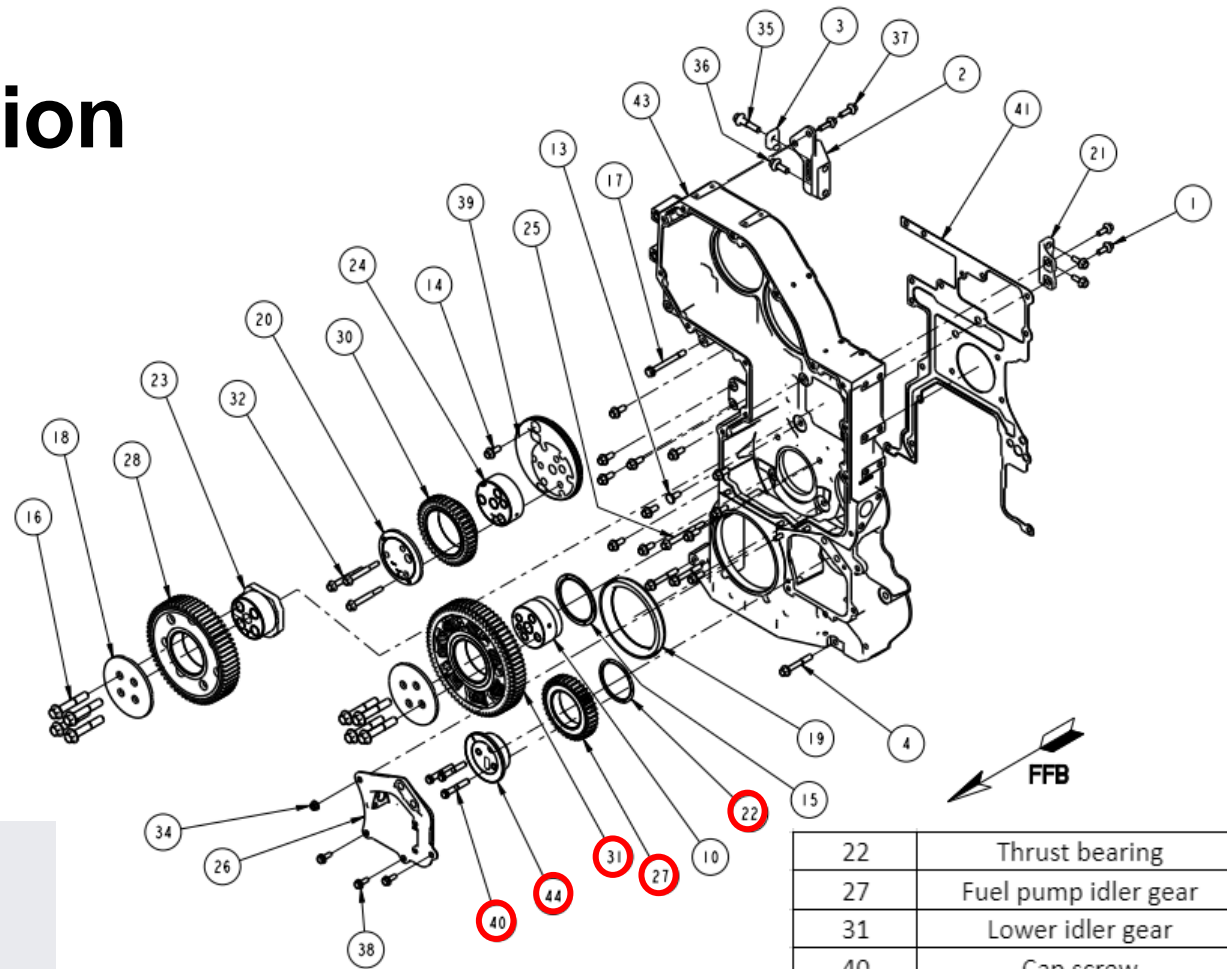
Fuel Pump Idler Gear Location

Assembly: bb1945

22	Thrust bearing
27	Fuel pump idler gear
31	Lower idler gear
40	Cap screw
44	Idler shaft

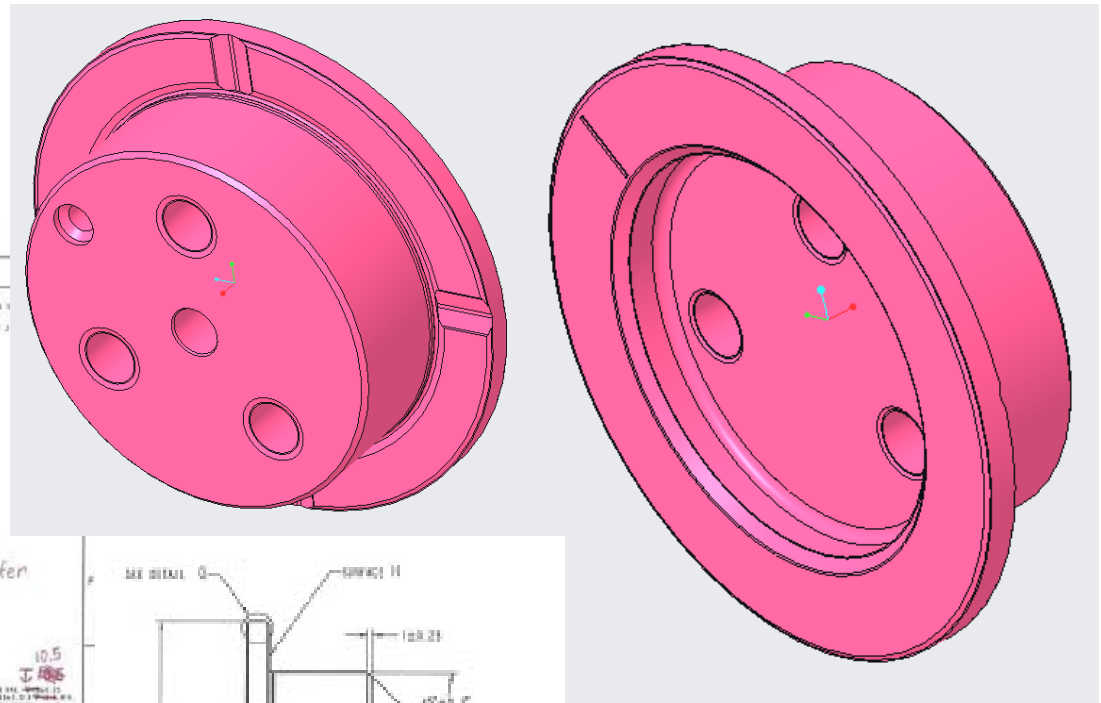
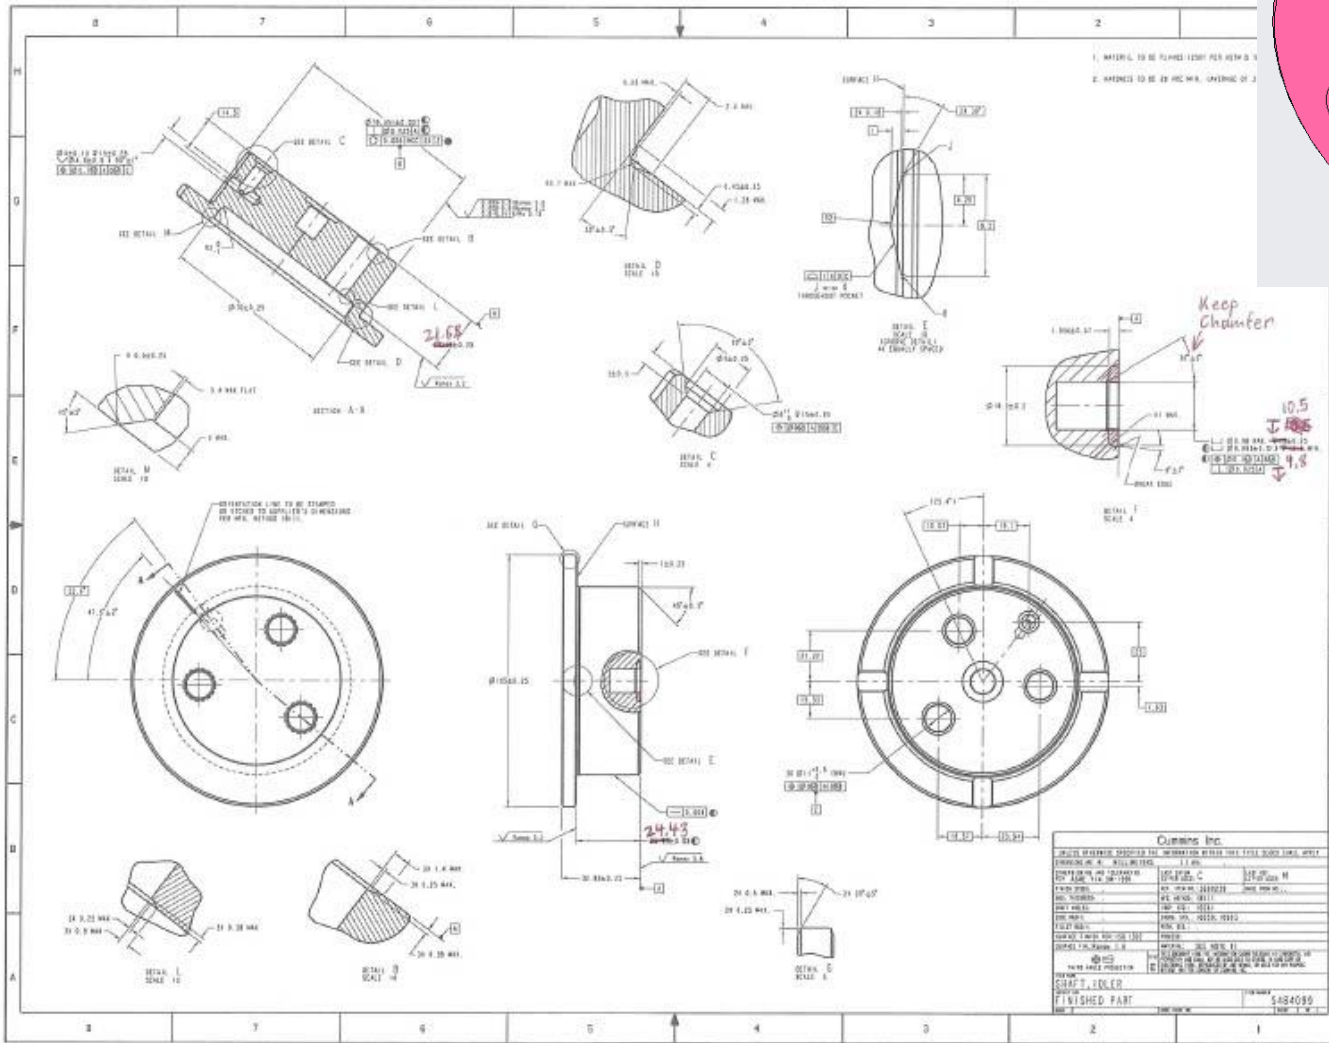
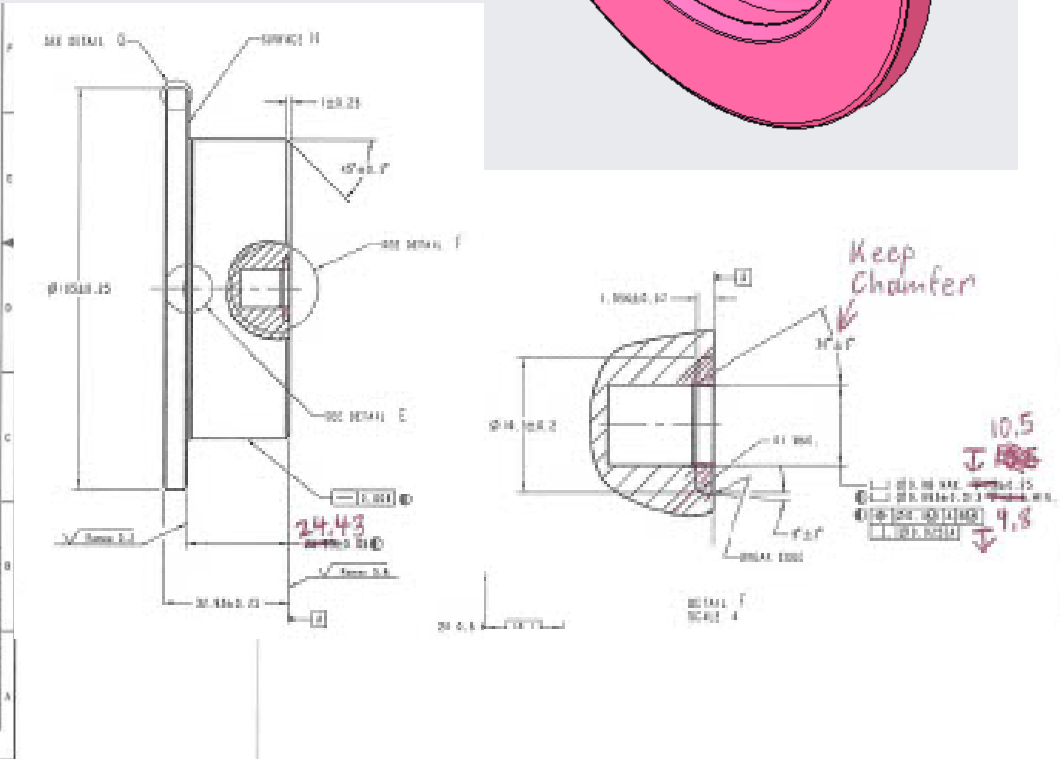
Redesign Process

- Key design differences between systems
 - Idler shaft cap screw holes in different positions relating to the centerline
 - Idler shaft cap screw hole diameters are larger for the adjustable design
 - Adjustable design idler shaft is 2.3 mm narrower for plate thrust bearing
 - Adjustable design idler shaft has larger counterbore for stabilizing plate
- Fixed idler shaft redesign
 - Reduced the width of the thinner section of the idler shaft by 2.5 mm to accommodate a plate thrust bearing rather than a ring
 - Reduced the depth of the dowel pin hole by 2.5 mm to account for the additional space taken by the plate thrust bearing
 - Removed the obsolete O-ring seal and filled in the space within the idler shaft that it occupied

- Commonized plate thrust bearing
 - Eliminated the ring design
 - Modified original part 3690851
 - Fit to the Idler shaft for the non-adjustable design
 - Moved cap screw hole positions
 - Accommodate difference in hole positions for both idler shafts
 - Changed hole diameters to 12.02 mm
 - Each hole fits the corresponding screw position of both idler shafts
