End of Co-op Presentation

By: Jessica Nicholson

Water Transfer Tube Weld Cracking Investigation

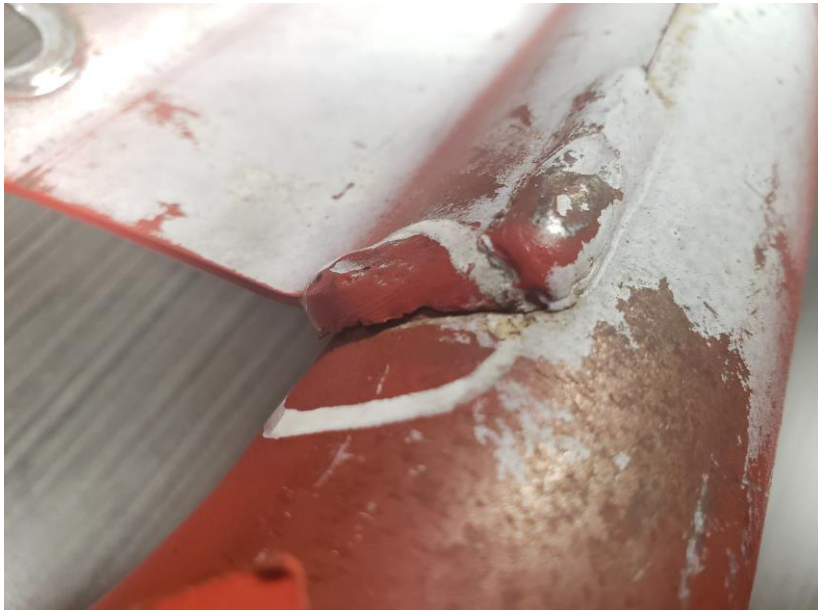
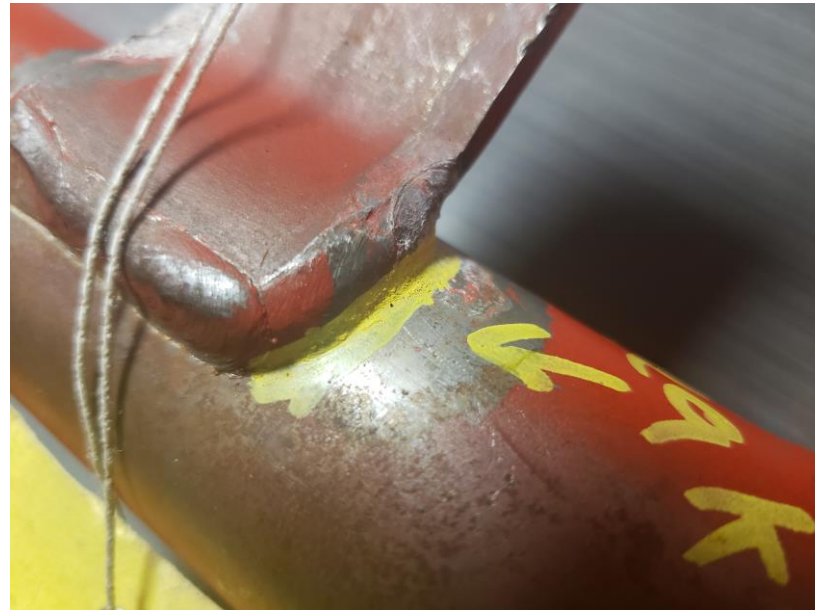
- Failure along circled weld joints
- Both tubes crack along weld joint connecting bracket to tube
- Crack can get worse and lead to coolant leak if not identified and fixed
- Many claims of cracked welds with leaking coolant

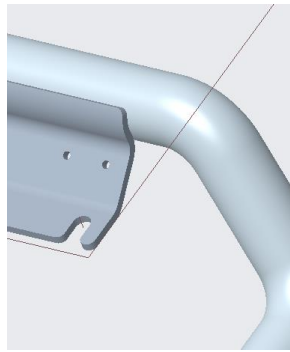
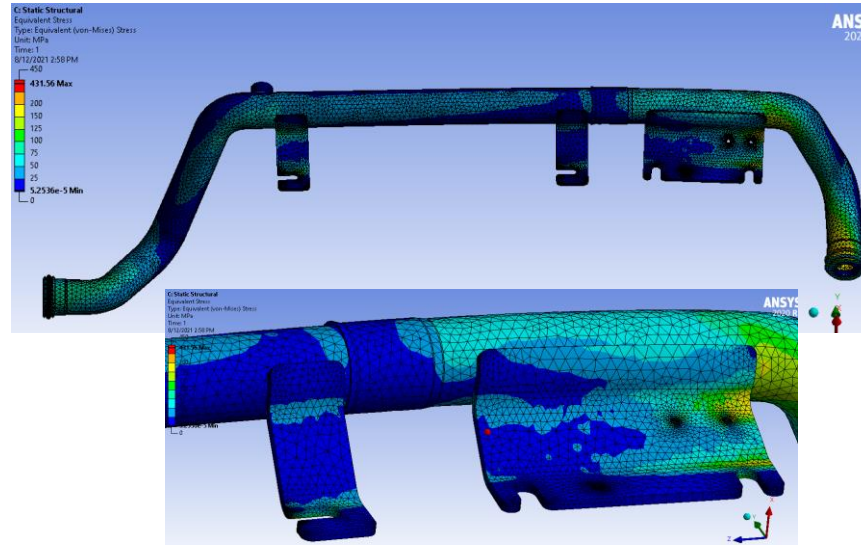
Old
Bracket:
4.8 mm

- Two ANSYS simulations performed for 1.5 and 4.8 mm bracket thicknesses
 - Given displacement perpendicular to each bracket face = 1 mm
 - Same fixed support points at both ends of transfer tubes
 - Both full-system simulations measure equivalent stress
- Locations of interest – each welded bracket-to-pipe joint
 - Stress measured at these locations; stress distribution shown
 - Stress distribution compared between simulations

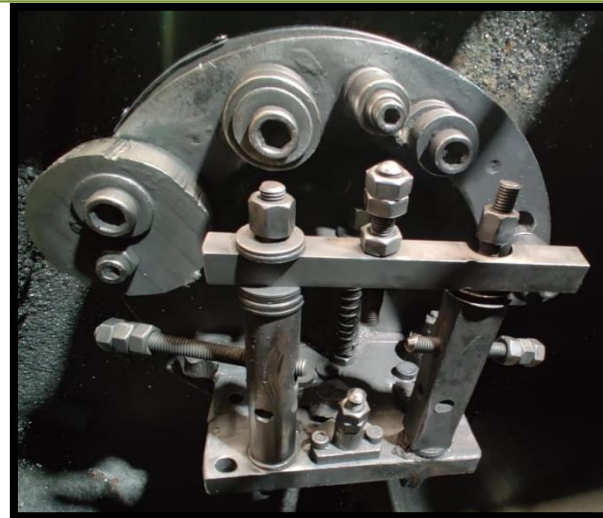
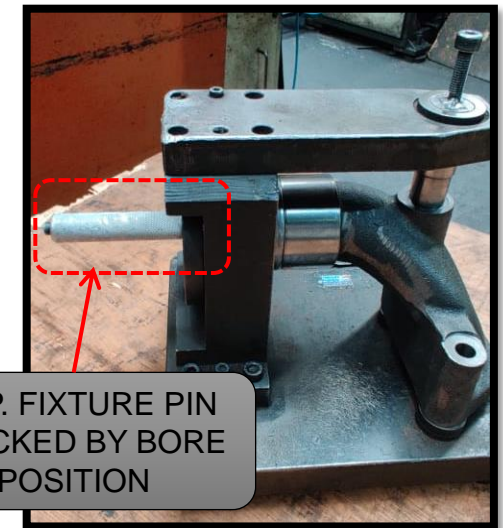
Manual Clamping Production Method

- Connector supplier: Mahabal Metals
- 3 hydraulic and 1 manual clamping mechanism in each CNC machine
- Manual clamping mechanism identified as cause of dimensional issues
- Replaced manual clamping mechanism with hydraulic clamping mechanism
- Should significantly reduce error in positioning from manual mechanism

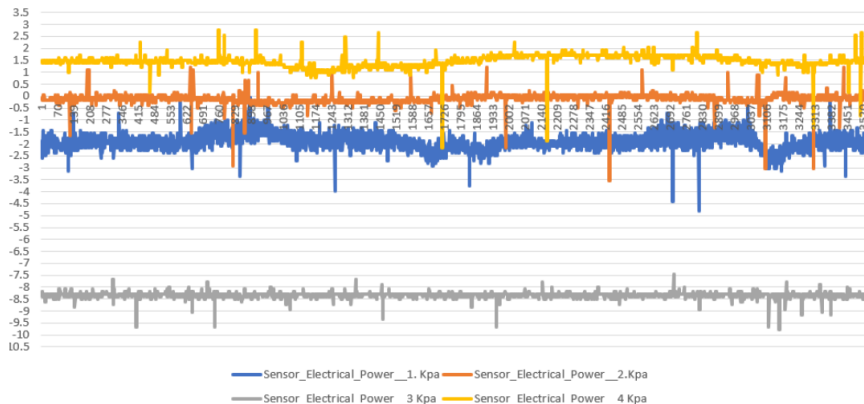
- Internal operating pressure and temperature gauges
- Peak measured operating temperature = 130 C
- Measured internal operating pressure at each gauge location
- Pressure measurement observations
 - Pressure in drain tube above check valve is negative
 - Pressure in below check valve averages 0 kPa
 - Check valve opens:
 - To allow drainage when internal pressure above check valve rises or below drops
 - When pressure within the tube above the check valve exceeds the pressure below
